Examination of Aluminum Containers for Extended Wet Storage of Non-Aluminum-Clad Spent Nuclear Fuel

Lisa N. Ward¹, Chris Verst¹, Marvin Trimm¹, Kevin Counts¹, Sean Boland²,
Michelle Hromyak², Robert Sindelar¹
Savannah River National Laboratory¹ and Savannah River Nuclear Solutions²
Aiken, SC

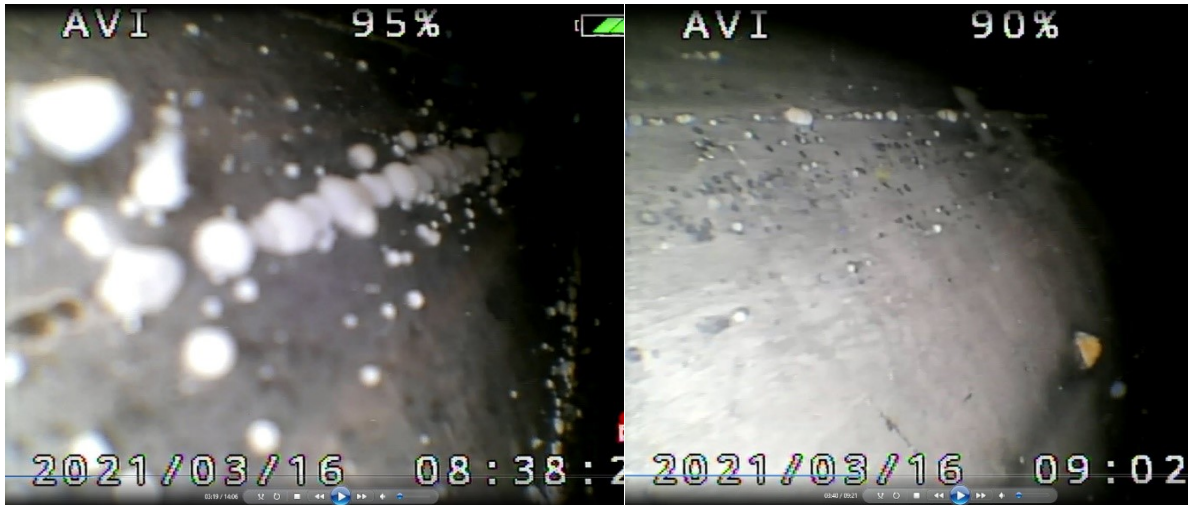
Figure 5. Corrosion nodules.

- All bundles showed general corrosion in many forms of aluminum oxide nodules, probable aluminum chloride nodules, scaling corrosion, and pitting. While these features were present, it is unknown whether the corrosion initiated in L Basin or if it were present before the bundles were placed within the basin. None of this minor general corrosion was deemed deleterious to the integrity of the bundle (Figure 5).

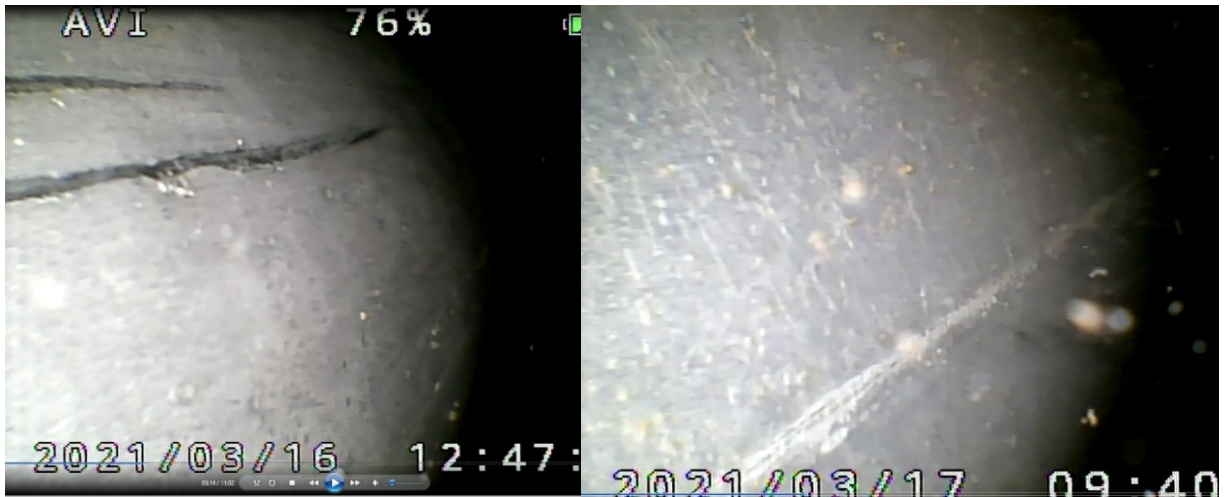
Figure 6. Abrasions on bundle sidewalls.

- All bundles contained scratches, scrapes or abrasions on their sidewalls. Many were clearly created before the bundle was placed in the basin and perhaps before the bundle was loaded with fuel. Circumferential scratches with associated orange or brown corrosion is most likely due to turning the bundles on steel racks, leaving a steel deposit on the aluminum surface. None of these features were currently deleterious to the bundle integrity (Figure 6).

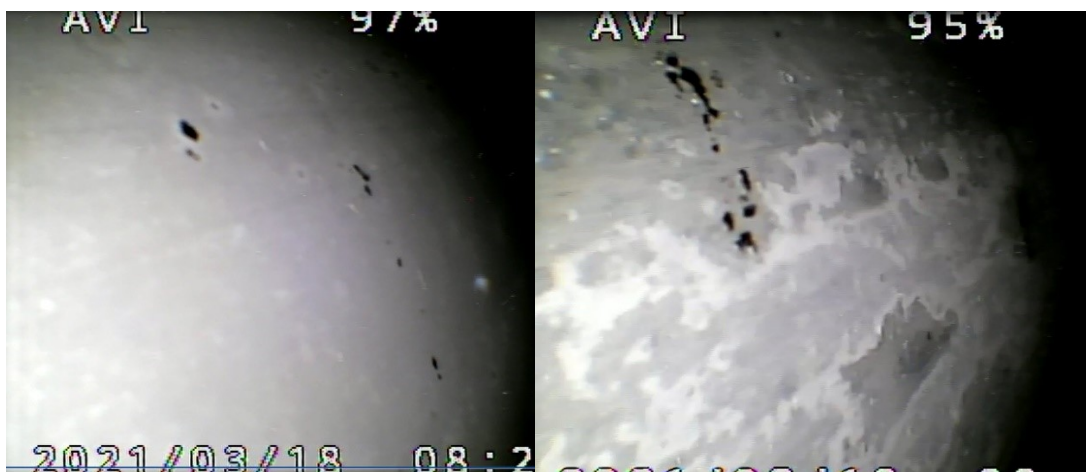
Figure 7. Black features on bundle sidewalls.

- Small black features of different sizes were noted at many areas on most bundles. The cause of the black features was not definitively identified. Potential causes could be patches of dark-colored oxide, shadowing from raised nodules, or local penetration. An additional examination is planned for August on L bundle 0845 with supplemental lighting. The in-progress calculation on bundle integrity shows the high tolerance of the bundles with through-bundles defects against all handling loadings (Figure 7).
