The NLI-1/2 Tipover Accident

A.H. Wells, J.M. Viebrock, G.N. Dixon, Jr.

Nuclear Assurance Corporation, Norcross, Georgia, United States of America

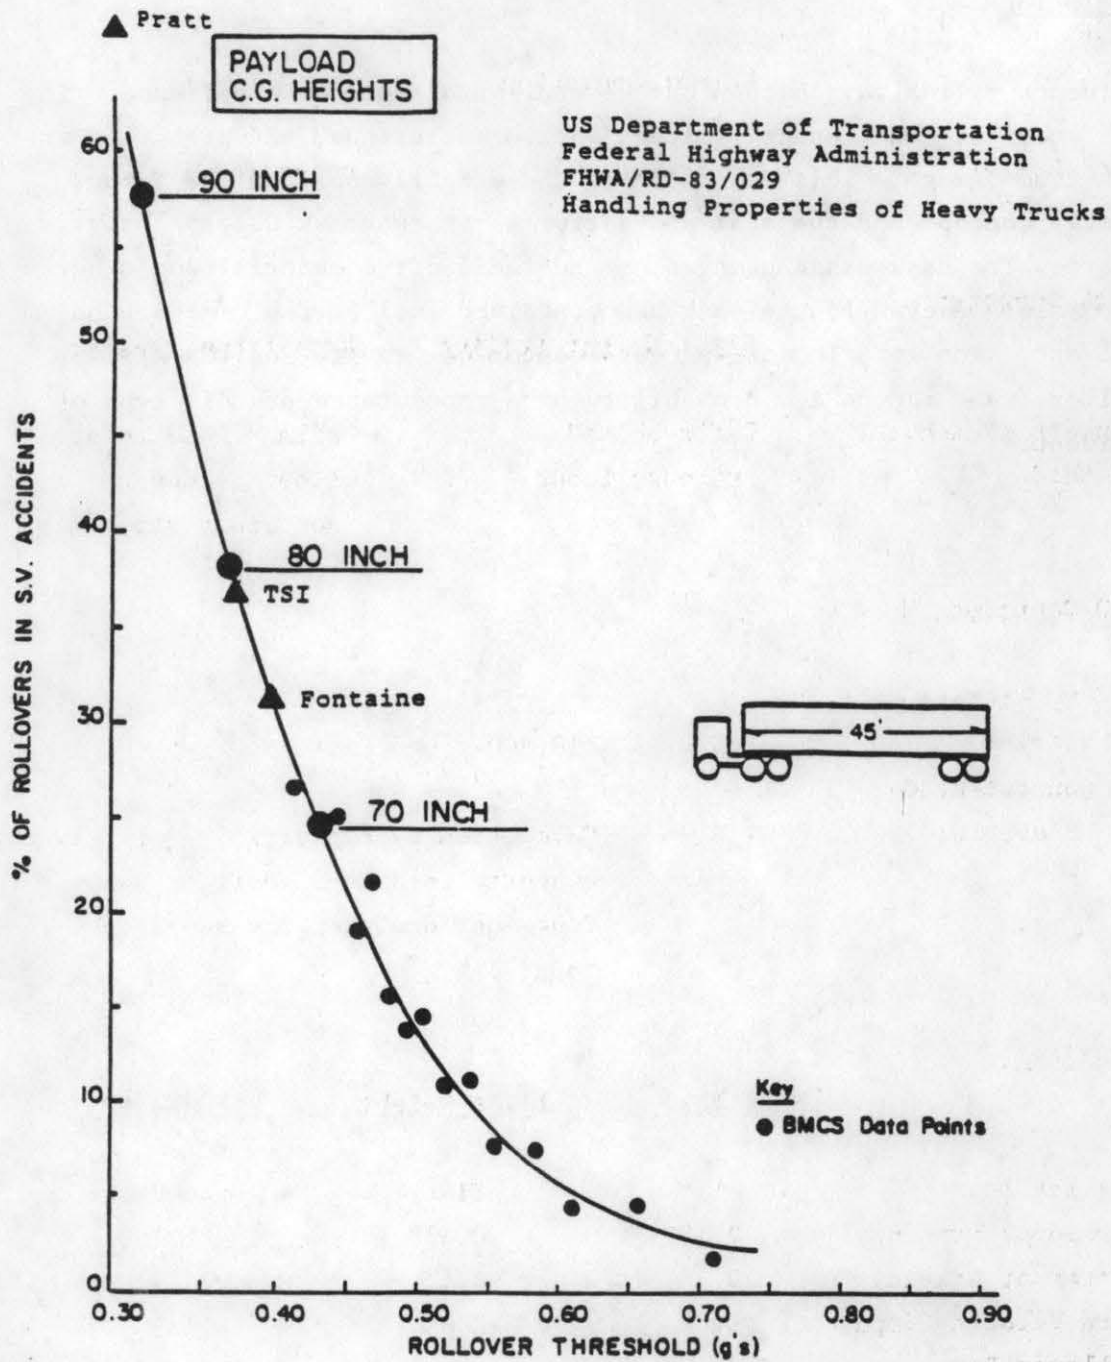
FIGURE 1
TIPOVER PROBABILITY

Figure 1 shows that the cask in the ISO container on the light-weight trailer had too high a center-of-gravity (CG), and this caused a relatively high probability of tipover in any abnormal conditions. NAC decided to change to a drop-frame trailer manufactured by the Fontaine company, and the light-weight trailers were withdrawn from service. The Fontaine drop-frame trailer configuration lowers the CG below the original TSI trailer CG, and Figure 1 shows that this improves the

rollover probability by a factor of 2.1 compared to the light-weight trailer that actually tipped over. The torsional stiffness of the trailers was also calculated, as listed in Table 1, and indicates that the Fontaine trailer is as rigid as the TSI trailers and will not twist as easily as the light-weight trailer so that the chances of tipping are further reduced.

Overlay of Rollover Thresholds Representing Payload
C.G. Height Variations onto Accident Data Curve

The principal corrective actions intended to prevent recurrence of this accident were to replace the light-weight trailers with new drop frame trailers, which lowered the cask center-of-gravity considerably. The replacement trailers have a much stiffer frame, which resists the twisting loads caused by turns or jolting of the trailer by obstructions in the roadbed. The ISO container configuration may only be used when shipping fuel outside the continental United States, and the original
