## **Inside Repair of a Type-B (U) Cask in Operation**

*P. Dybeck*

*Swedish Nuclear Fuel and Waste Management Co, SKB*

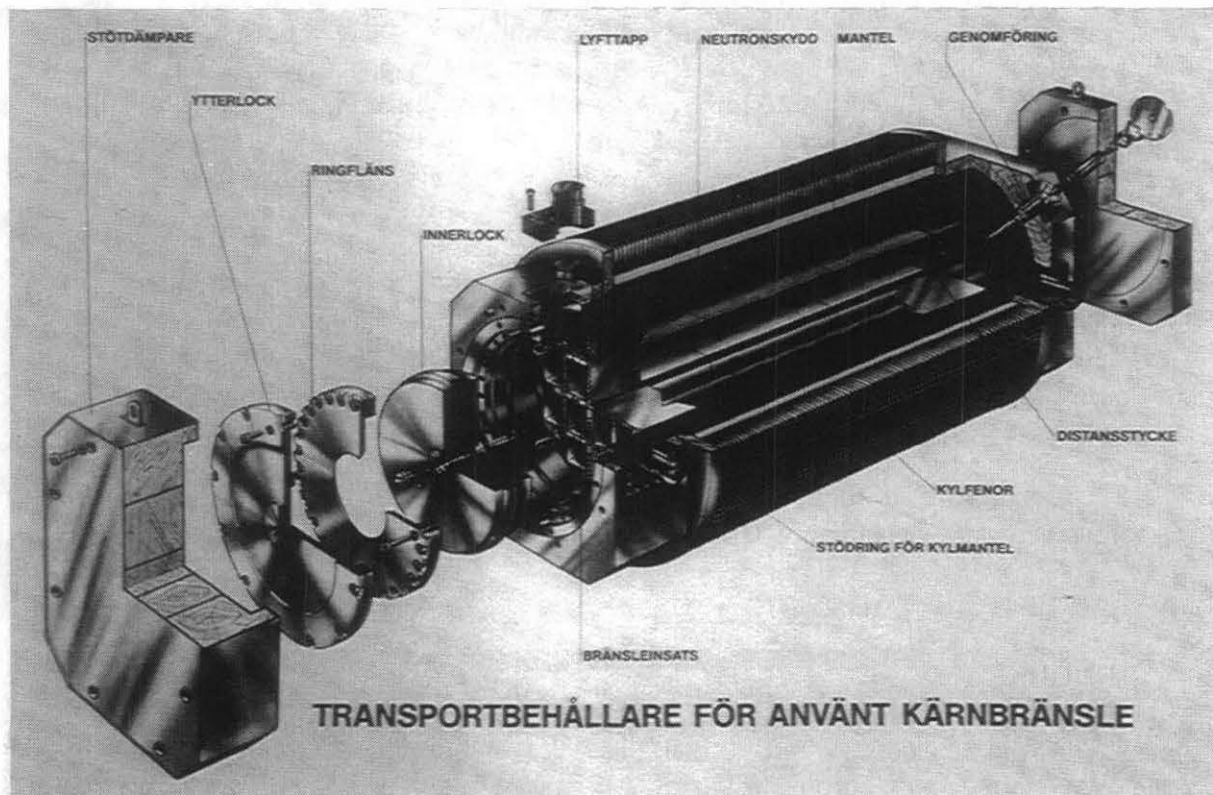
*Transport cask for spent fuel*

The cask inner surface was then checked by ultrasonic (UT) and penetrant testing (PT). The PT showed no cracks but the result of the UT showed that the stainless steel lining inside the cask had become separated from the base material on numerous spots. All casks were taken out of operation and checked by UT testing. The result showed that no damages had occurred on the other casks and not even on the two casks where the same welding method had been used.

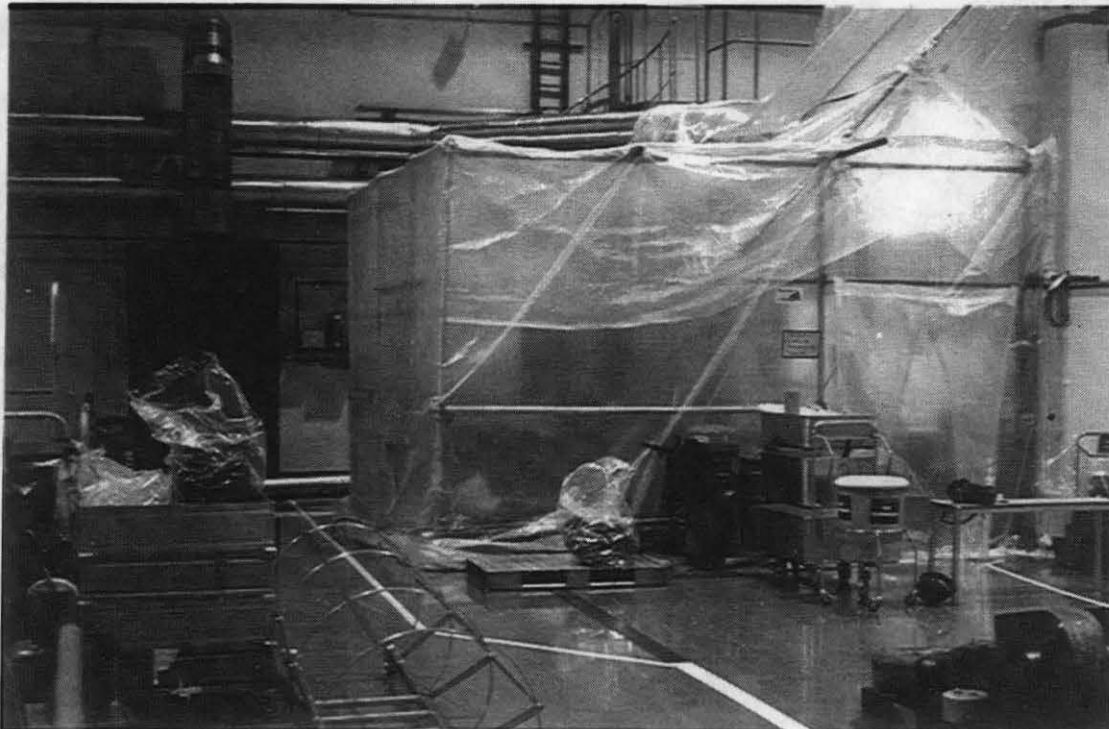
*Temporary workshop at CLAB*

An intermediate cask storage position in the cask reception building was used and equipped with all necessary installations and equipment for the repair.

The cask was equipped with circular plates at the ends and placed on rollers to allow rotation during the welding operation. Ventilation pipes were connected to the cask bottom orifices and led by a filter to the main ventilation system. The workshop was finally covered with plastic sheets which made it possible to continue the normal operation of CLAB during the repair period.

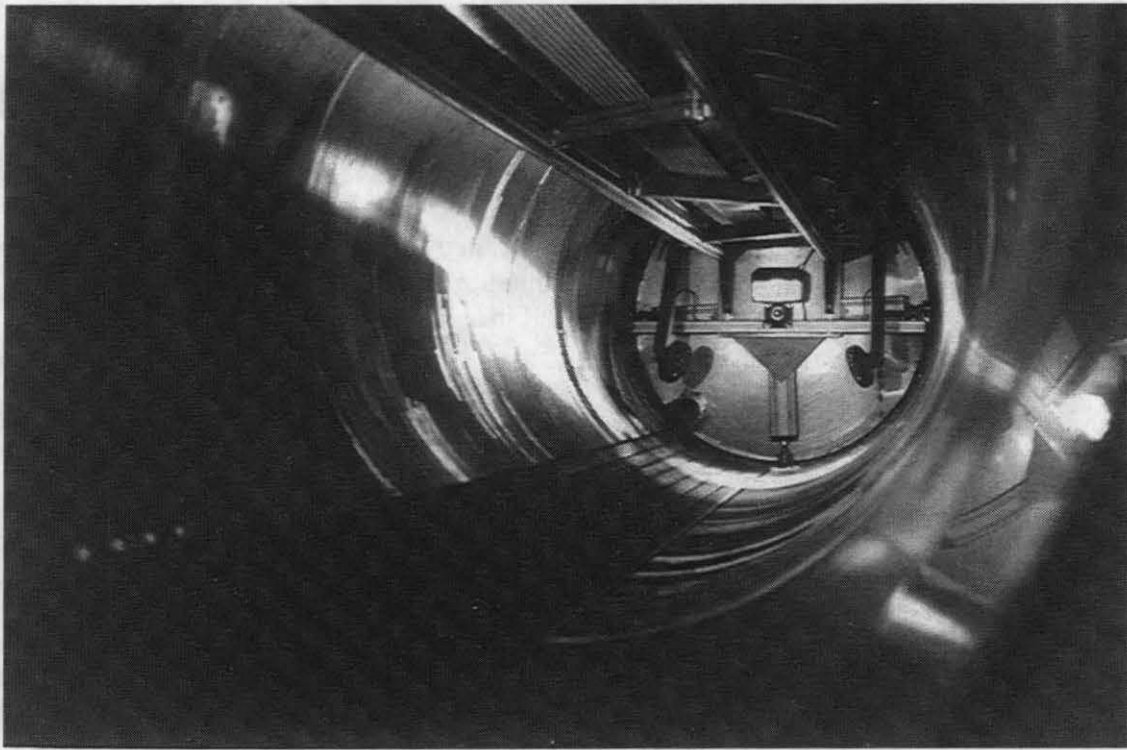
*Welding the new liner*

Due to the neutron shielding material around the cask, heat treatment after welding was not possible. A new welding method, developed by Uddcomb Engineering, for repair of digesters in the paper industry, was used. The method, called GMAW-P, Pulsed spray Gas Metal Arc Welding, implies that 50-mm broad and 2.5-mm thick stripes are welded along the cavity. Four layers were welded on top of each other. The automatic welding process was supervised by a third party inspection organization and was controlled via a video system. After welding of each layer an analysis was made of the welded material. The complete welding operation took 2 months, welding 256 stripes in four layers, corresponding to 200 m<sup>2</sup> of welded area. The work was performed in three shifts.

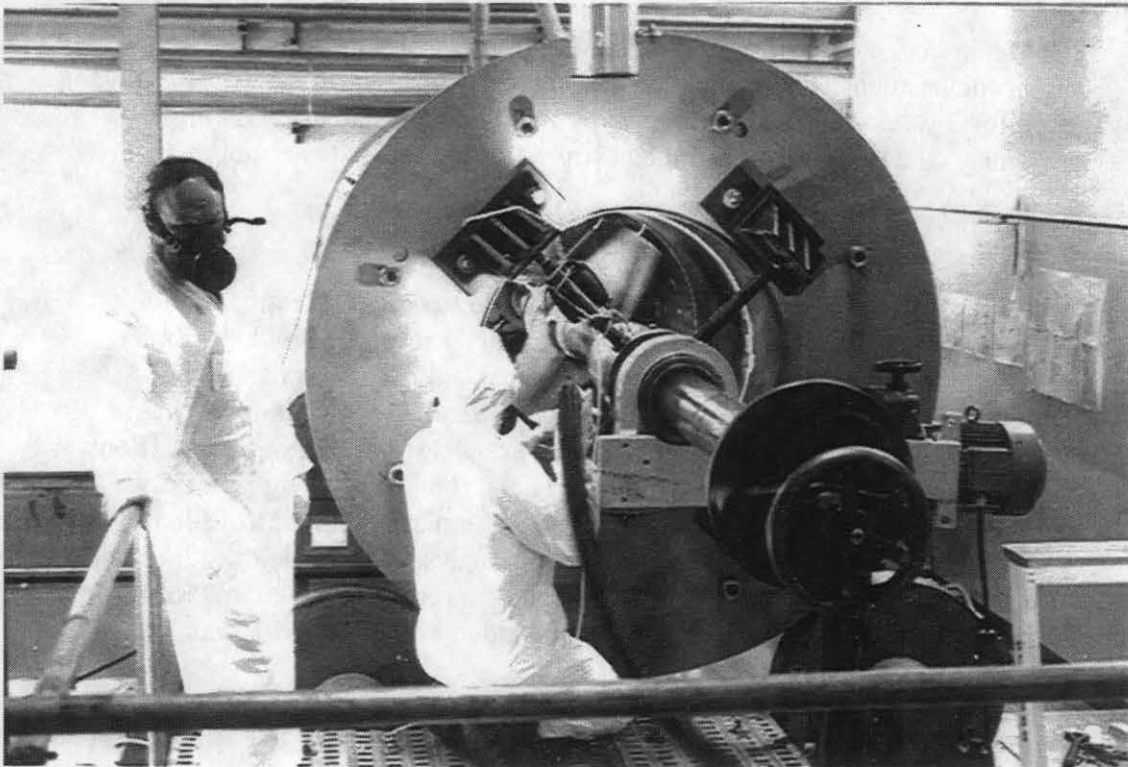
*Final machining*

The 14- day-long machining of the welded cladding down to final dimensions was done by using the same boring machine that had been used for removing the damaged cladding. .

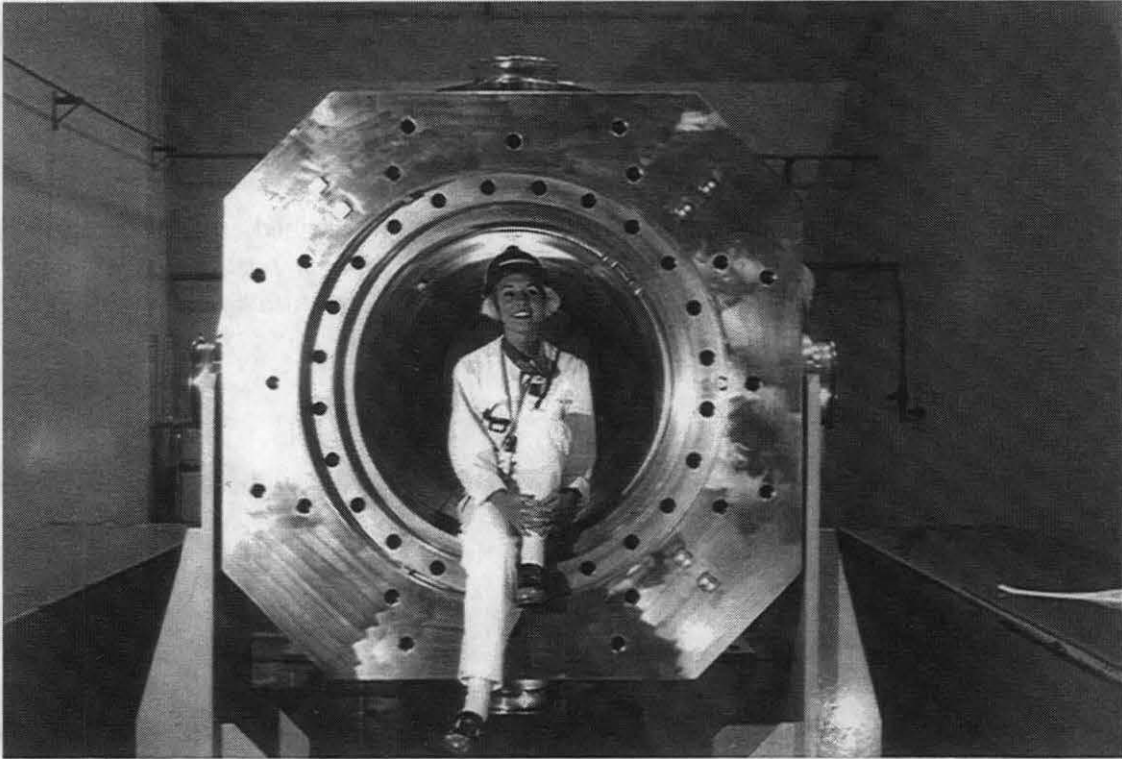
*Beautiful work*

During the complete repair process a third party inspection company, MRQ, approved by the authorities, had supervised the work and performed the tests specified in the inspection program. After the final machining, a final ultrasonic test (UT) and penetrant test (PT) was performed. The result was excellent and the welding method had shown to fulfill the special requirements for the repair. A new UT was done after 6 months of operation and showed no remarks.
