Lessons Learned from the Studsvik Ir-192 Transport Incident

Richard W. Boyle

U.S. Department of Transportation, Washington DC, USA

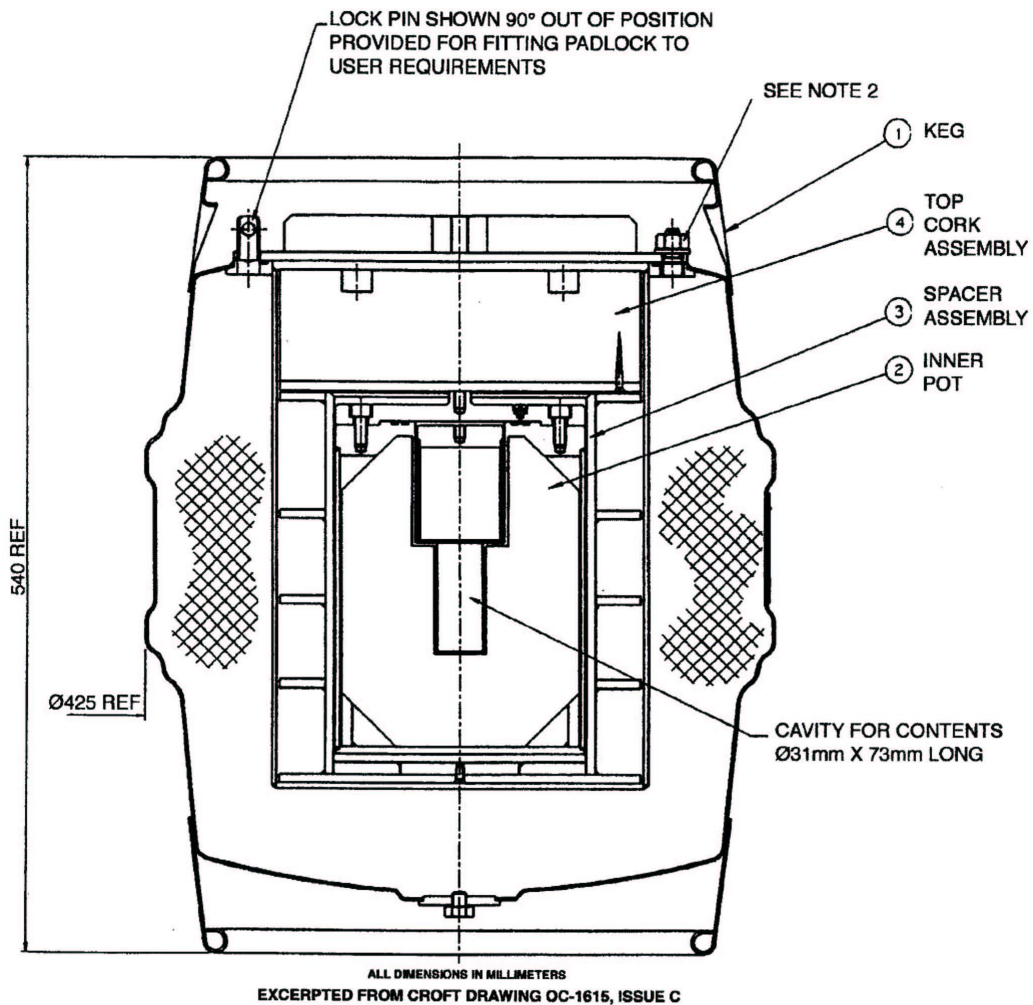
Figure 1: Section View and Selected dimensions of the 2835A

Outer package diameter	425 millimeters
Outer package height	540 millimeters
Shielded vessel diameter	167 millimeters
Shielded vessel height	246 millimeters
Shielded vessel cavity diameter	31 millimeters
Shielded vessel cavity height	73 millimeters
Maximum weight, including contents	127.1 kilograms

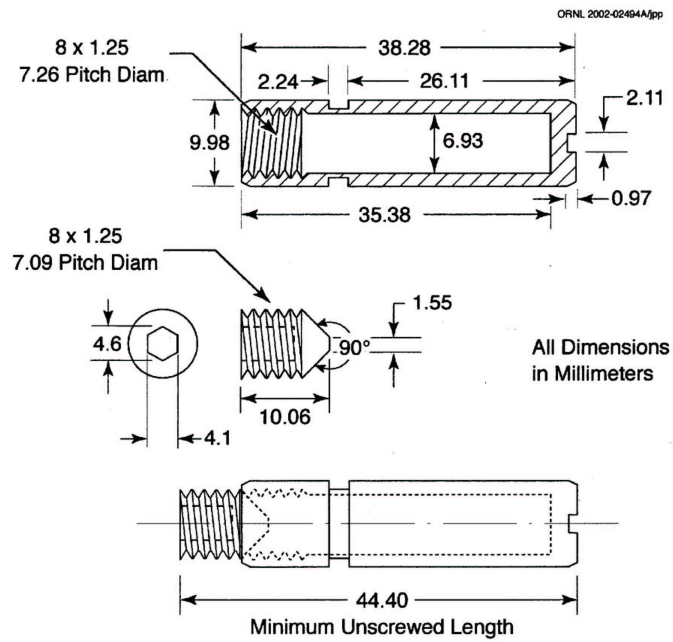
Figure 2: Ir-192 Source Capsule

- a) Opening the package: In order to determine the cause of the incident and allow SPEC to recover the most Ir-192 as possible, a procedure to open the package was needed. After consulting with the local authorities and determining their capabilities, SPEC decided to build a large, temporary hot cell capable of handling the entire 2835A. The inner shielding pot was then transferred to an existing hot cell and opened. Upon opening the shielding pot, SPEC confirmed that the root cause of the incident was failure of the two of the three inner, screw top capsule lids. Briefly, transport vibration had caused these poor fitting, unsecured screw caps to fall off and the iridium wafers had migrated to unshielded positions.

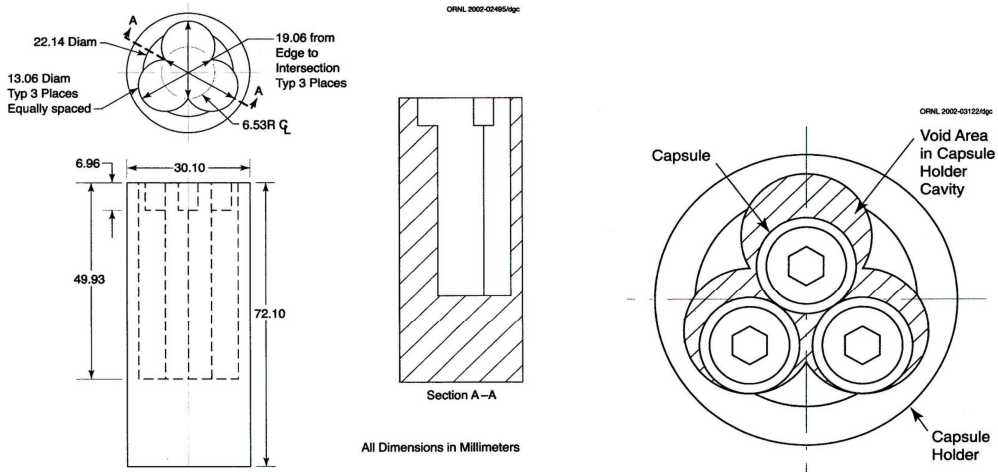
Figure 3: Ir-192 Source Capsule Holder

The package contained 366 TBq of Ir-192 in the form of metallic wafers. The wafers measured 0.025 mm in diameter and 0.0025 mm in height and were contained within three screw top metal capsules placed within source holder within the shielded container. The capsules used in this shipment were approximately 35 mm in length and 10 mm in diameter are shown in Figure 2. The source holder, which is not listed on either Certificate of Competent Authority, is shown as Figure 3.
