# Certification Test for Safety of New Fuel Transportation Package

## 1. PROGRAM OUTLINE

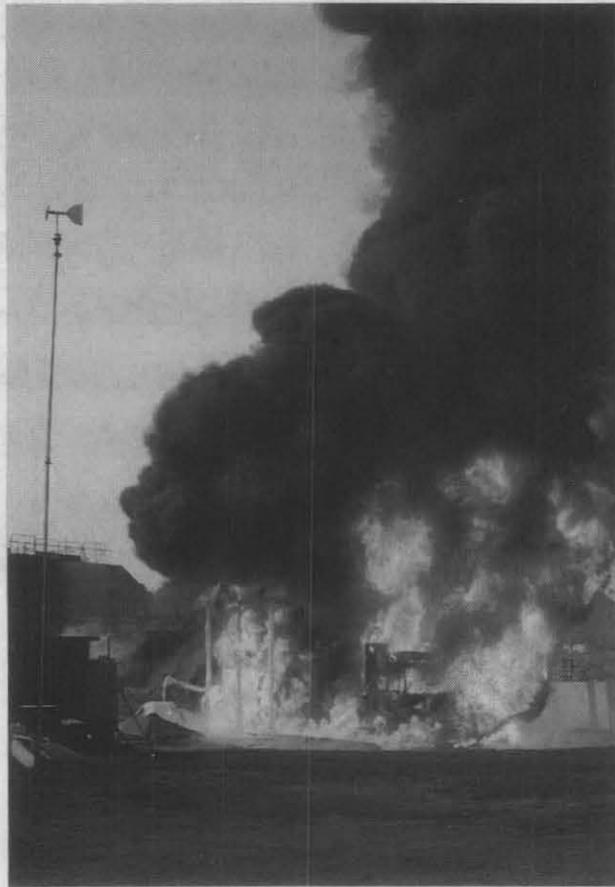
Figure 4 Fire flame 5 minutes after lighting

Figure 4 shows fire flame at 5 minutes after lighting.

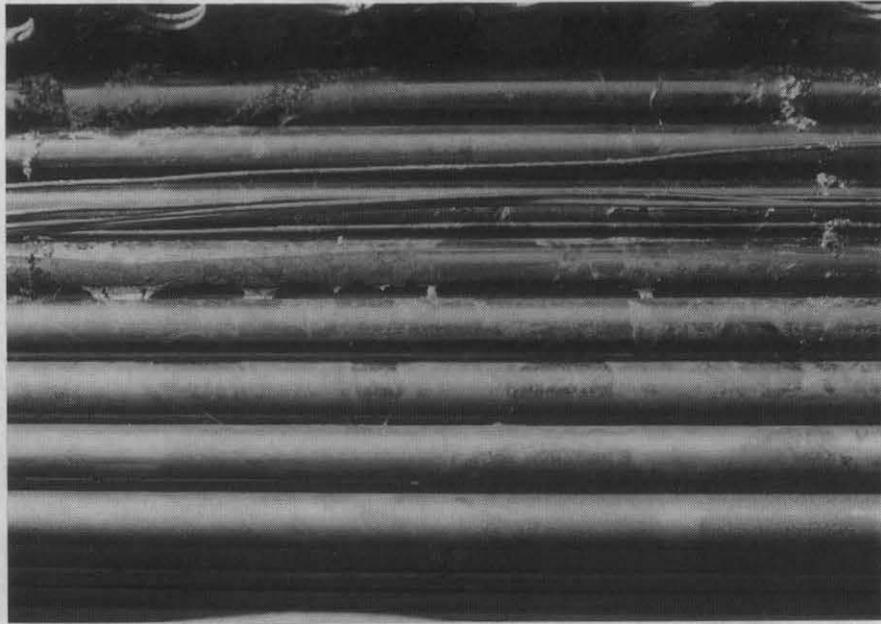
Figure 5 Rods of BWR-type mimic fuel bundle after test

- (1) The wooden outer container was burnt out 15 to 30 minutes after lighting.
- (2) The loading platform of truck made of wood was completely burnt out. The chassis frame of truck was bent due to heat and weight of the specimen.
- (3) Inner container made of steel showed a little deformation. But the bolts connecting the container and the lid were not broken.
- (4) The color of fuel rod surface was dark grey or black and was supposed to be the color of oxide of Zircaloy. Also coaltar-like material adhered to the rod surface.
- (5) Any deformation of the fuel rod such as puncture, crack, bend or swell was not observed.

Figure 5 shows rods of mimic fuel bundle after test.

Surface color of BWR-type fuel assembly was dark grey that is supposed to be the color of oxide of Zircaloy. As for PWR-type fuel assembly, the condition encountered during fire test caused no change to the outlook of the rod element.
