INVESTIGATION OF A SPENT FUEL CASK BESIDE AN EXPLODING PROPANE TANK

Bernhard Droste and Bernd Schulz-Forberg

Bundesanstalt für Materialforschung und
12200 Berlin, Germany

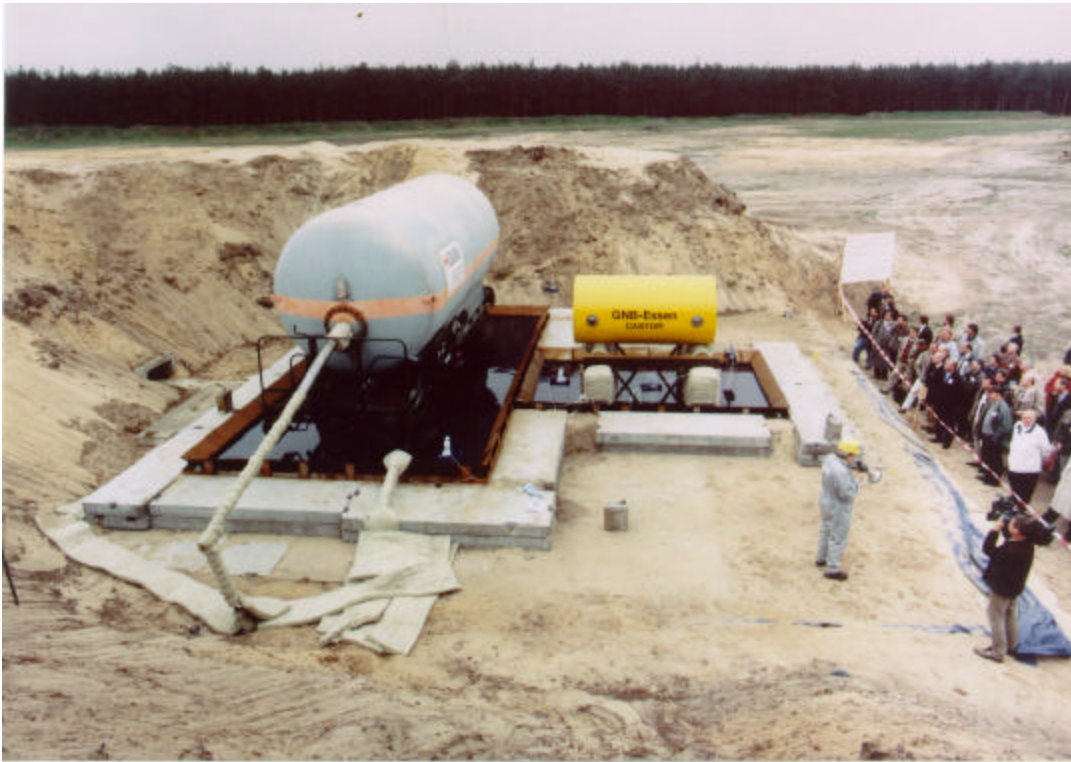
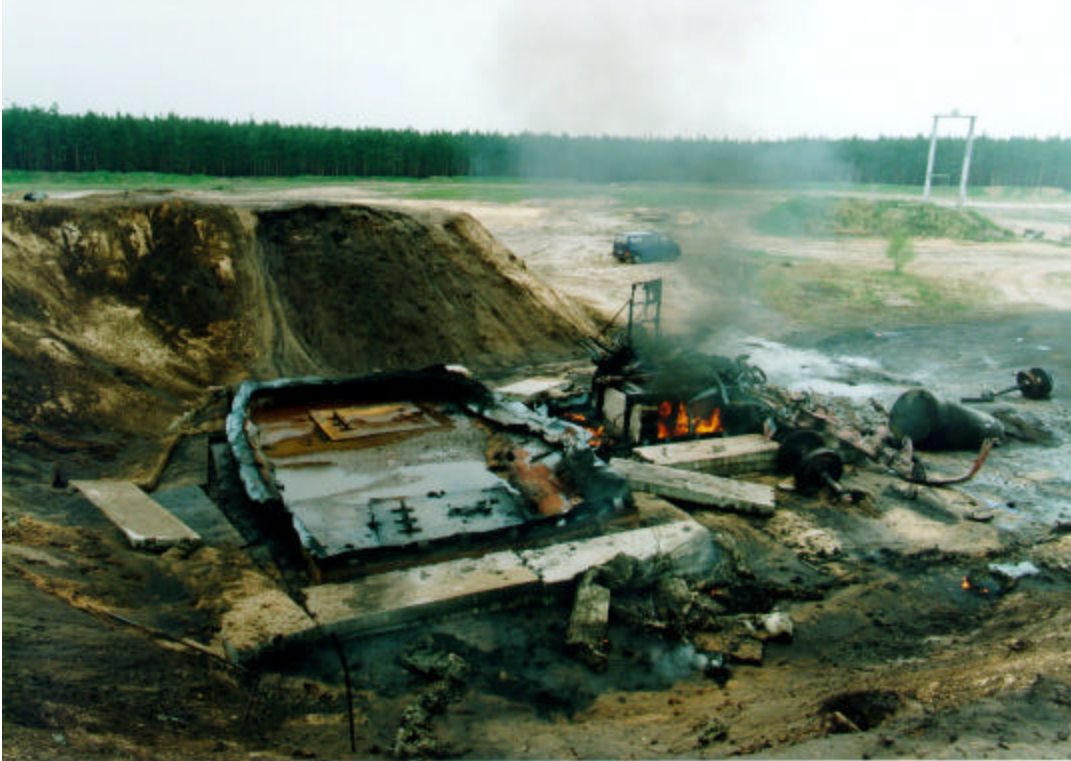
Figure 2. View of the Test Facility
a) Before the Test (above): Propane Tank (left) and CASTOR Cask (right) above Fuel Oil Pools
b) After the Propane Rail Tank Explosion (below)

The empty cask with a weight of 22,450 kg was positioned horizontally on a massive steel frame that was thermally insulated and supported by two concrete slabs. The cask axis was perpendicular to the propane tank axis, with the cask lid side facing to the propane tank as shown in Figures 1, 2a and 6. The cask was instrumented with two thermocouples (penetrating the lids through leak-test ports and bore holes) for temperature measurements close to the large metallic seals of the primary and of the secondary lid. Flame temperatures were measured by two thermocouples 100 mm from the lid horizontal diameter. The CASTOR cask was positioned above a separate fuel oil pool with the dimensions of 3.5 m x 5 m directly beside the LPG rail tank car pool.

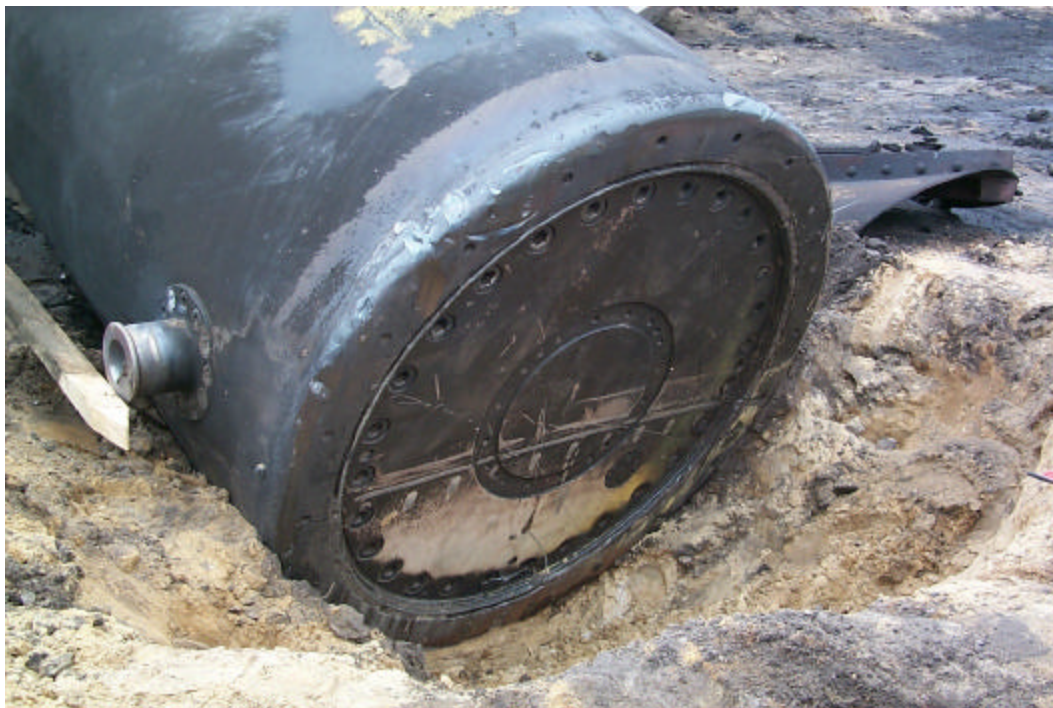
Figure 3. Excavated Lid Side of the CASTOR Cask with Imprints of the LPG Tank Support Saddle on the Outer Lid of the Cask

As a consequence of the propane tank initial rupture at the back furthest from the cask, the rupturing tank was accelerated rocket-like onto the CASTOR cask. The rail tank car hit the CASTOR cask at the upper half of the lid. The tank impact area could clearly be identified as the part where the tank shell was rivetted to the rail carriage. The imprint of this tank car area was found on the surface of the CASTOR cask secondary lid (Figure 3).

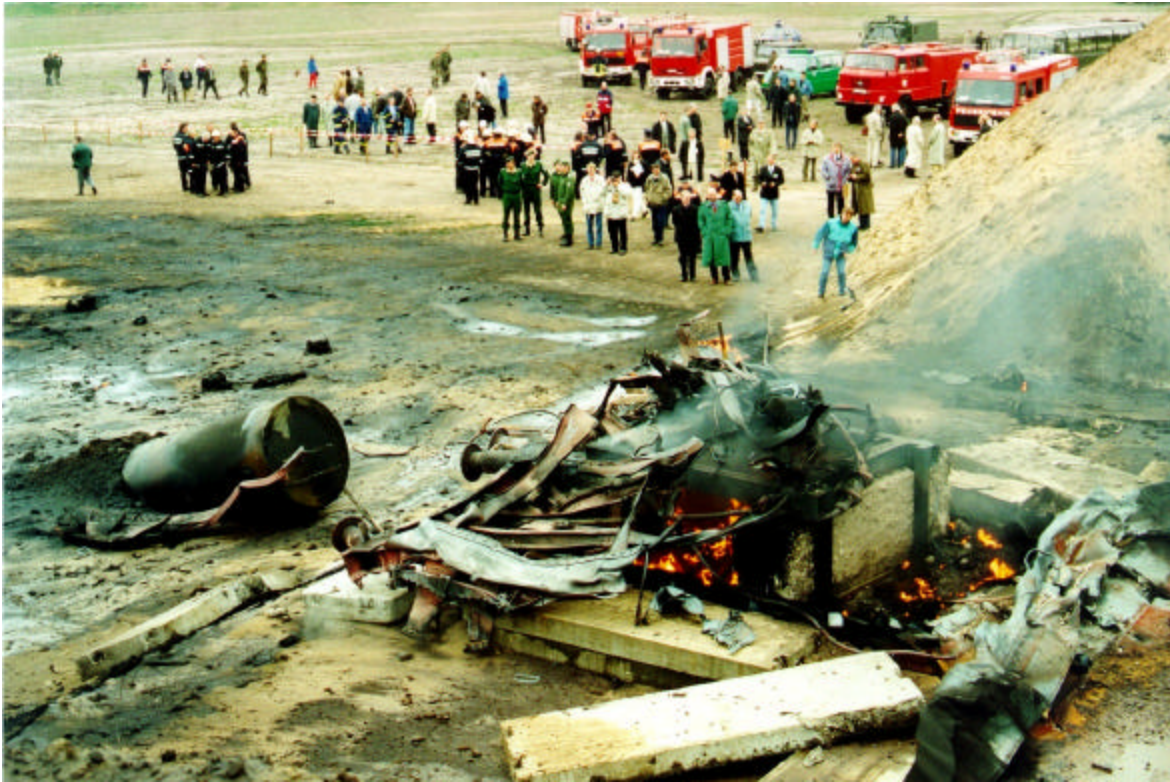
Figure 4. Fragments of the Rail Tank Carriage after the LPG Tank Explosion

The deformed parts of the rail carriage were found at the steel support where the CASTOR cask was positioned originally (Figure 4). The combined impulse of the rail car fragments and the explosion moved the support frame 0.5 m away, and threw the CASTOR cask out of the test facility. The eccentric impact onto the cask lid caused the cask to rotate. The cask bottom corner touched the concrete slabs in front of the fuel oil pool, and, after rotation the CASTOR cask lid side crashed into the soil (Figure 5). The CASTOR cask motion is shown in Figure 6.

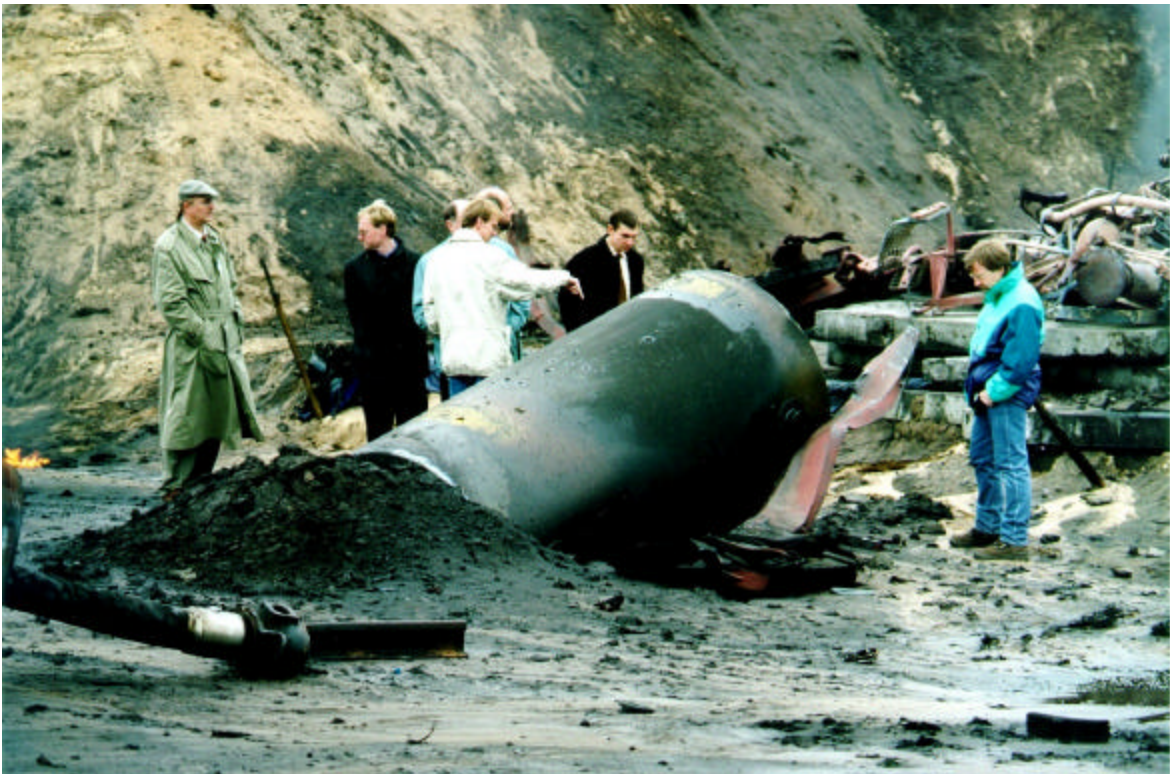
Figure 5. CASTOR Cask Thrown out of the Test Facility, with its Lid Side Crashed Into the Soil
