Unique Problems Associated with Response to a Transportation Incident Overseas

ABSTRACT

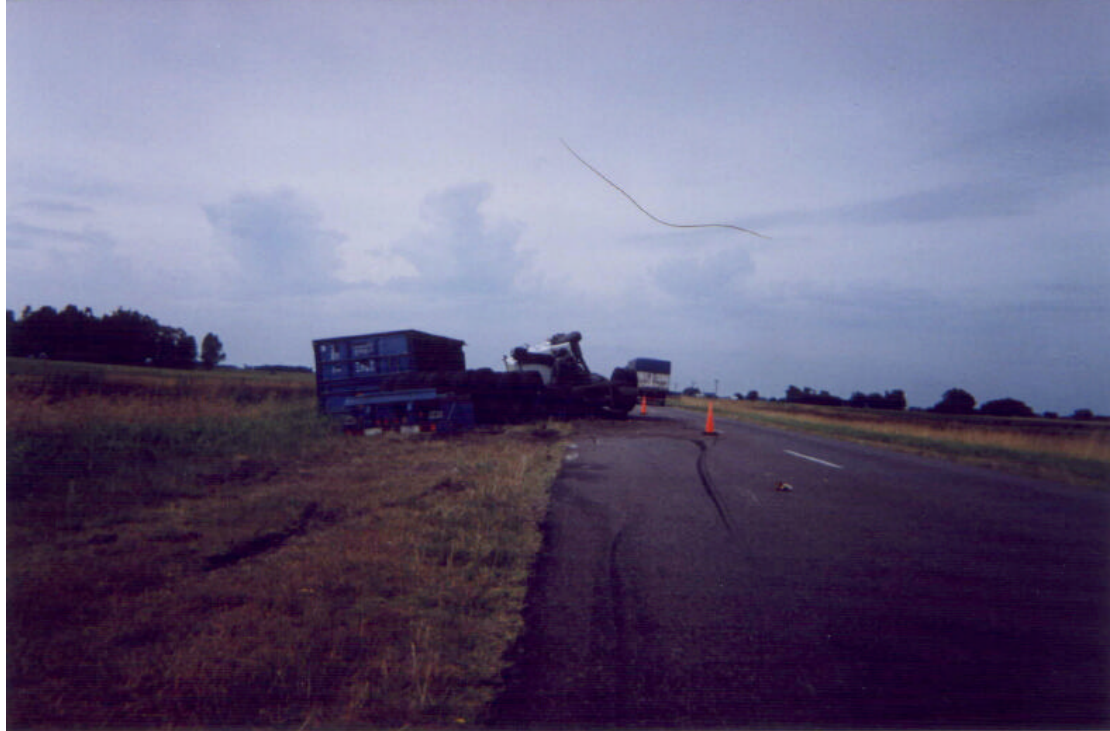
During the motor transport of the ISO to the port facility, the driver became distracted and rolled the shipment. The tractor and trailer were heavily damaged and the ISO container lay on its side, having broken loose from the trailer. The accident occurred very early in the morning of December 12, 2000, after DOE and the transportation contractor personnel had left the CNEA site. Although NAC had no contractual role in the equipment transportation back to the U.S., a representative of NAC's transportation logistics contractor, Schenker International, was contacted by the trucking company. He notified NAC who then notified DOE and DOE's transportation contractor of the event.

Tractor trailer and ISO container in the "post accident" condition

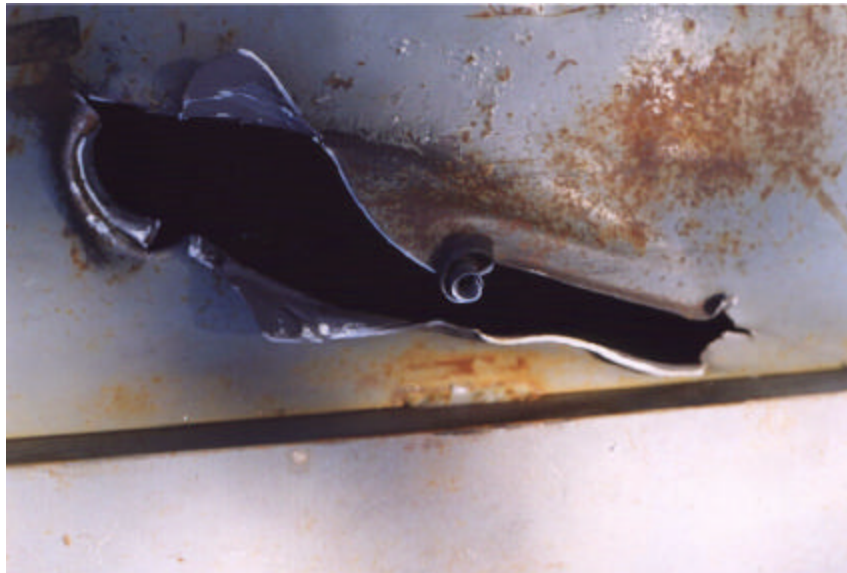
Package Inspection and Repair-The NAC equipment has a slight amount of fixed contamination requiring it to be shipped in IP-2 "strong tight" packages. "Strong tight" implies that the package is able to protect the contents from the normal rigors of transportation including vibration, shifting, transfers, etc. However, a "strong tight" package is not designed, nor expected, to survive a significant accident intact. If it is sufficiently damaged, it no longer meets the criteria for "strong tight" and is not suitable for continued transport, absent repair. As the photographs demonstrate, the NAC equipment was subjected significant accident forces. The IP-2 packages suffered considerable damage as did the ISO container. The packages and the ISO required repaired prior to shipping back to the U.S. This required an NAC representative qualified in DOT transportation regulations go to Argentina to supervise the repairs.

Damage to NAC IP-2 "Strong tight" Package

The NAC representative arrived on site toward the end of January and remained for 11 days. The first day, a Monday, was utilized to assess the damage to the packages and assure that they could be repaired. Otherwise replacement would have been necessary. A local welder was hired on a cash basis, credit or purchase orders would not be acceptable. NAC had to arrange for sufficient local currency in order to complete the process. The welder arrived on Wednesday and took measurements so that he could order the appropriate repair materials.

While awaiting repairs, the NAC representative removed the equipment from the packages so that a photographic record could be made, and dirt and mud could be removed. This formed the basis for the preliminary report to the insurance carrier. The Welder returned the following Monday and worked through Friday completing the repairs. All repairs were completed at the CNEA site, partially explaining their extended duration. The location away from the welder's shop, compounded by heat and humidity, were complicating factors. The Monday following completion of repairs, Schenker was able to obtain a customs clearance allowing the ISO to be transported to the port where it would sit awaiting export.

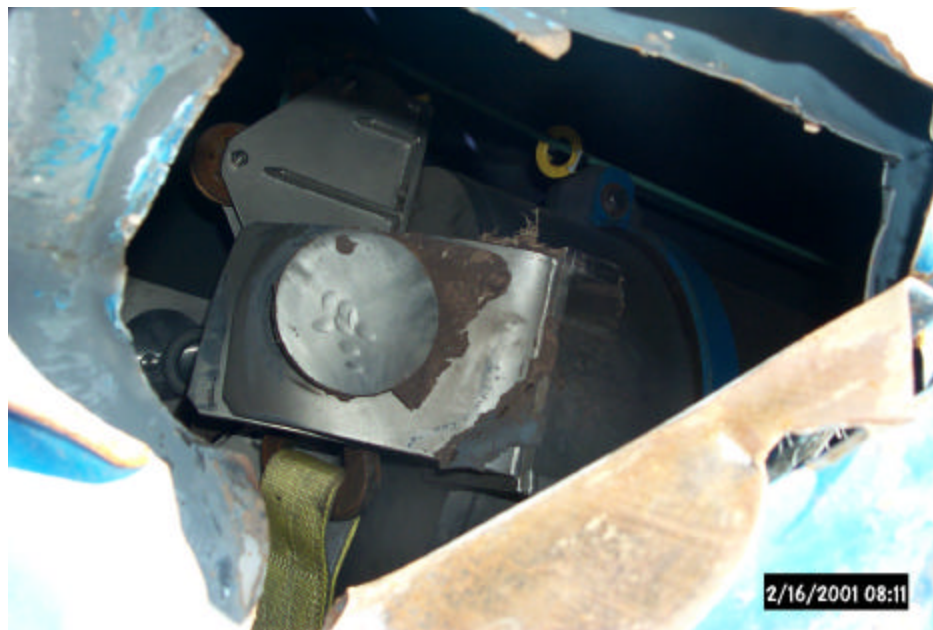
View into IP-2 Showing Damage to Transfer Cask Operator

Equipment Assessment-the assessment of the equipment is currently underway at a licensed inspection and repair facility. While all of the equipment was contained within the IP-2 packages, the heavier objects broke loose from their fasteners and sustained damage. The basic shielding elements of the equipment sustained little damage. The operating parts of shield gates, lead screws, bearings, and other equipment having little protection will require repair or replacement. We project that several more months before the repairs are complete, the equipment is returned to inventory, and the final accounting of the effects of the accident is complete.
