Review of BNFL's Operational Experience of Wet Type Flasks

Author: Mr D S McWilliam, BNFL International Transport, UK

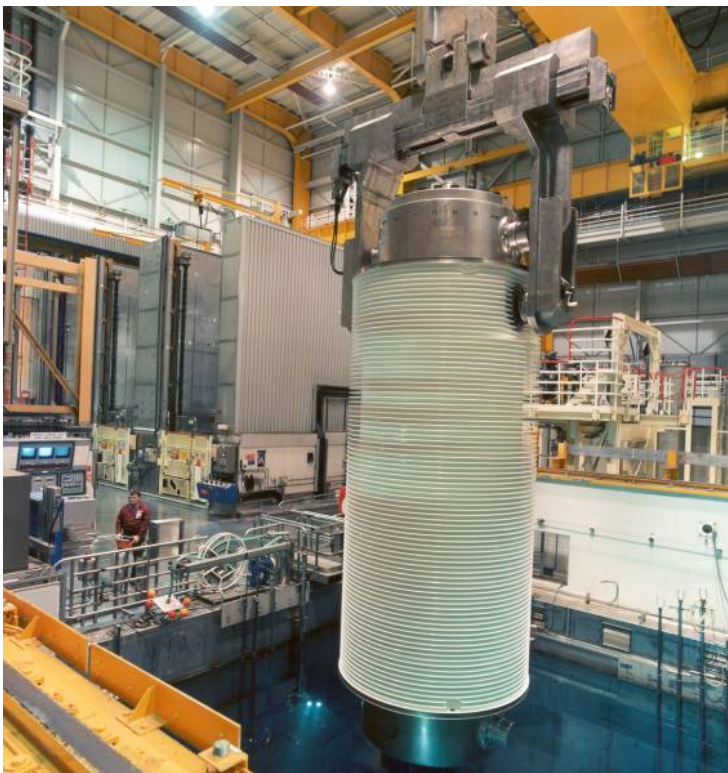
Fig1 THORP Receipt and Storage

In the UK the flasks were received at THORP receipt and storage facility (fig 1), a purpose built facility for receipt of wet flasks.

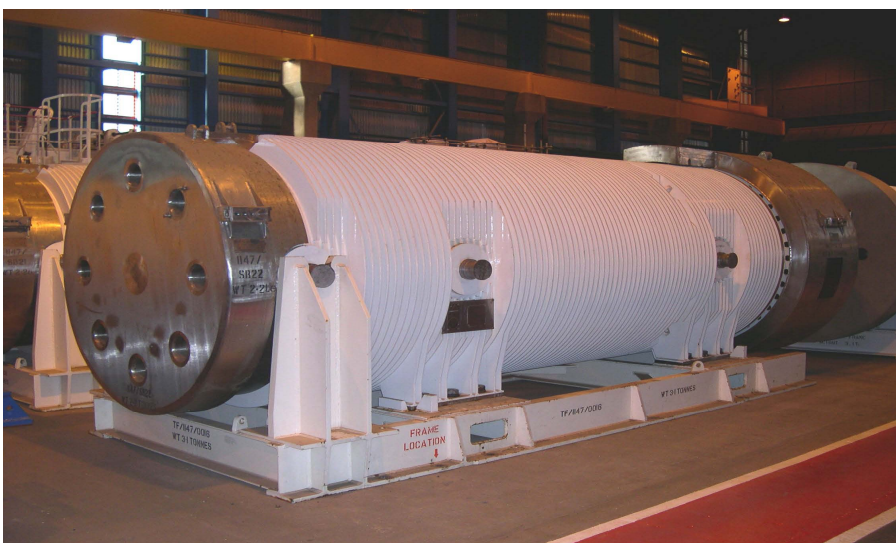
Fig 3 Excellox 4 Flask in Storage at Sellafield

The wet type of flasks, so called because it transports the fuel under water to provide neutron shielding from the fuel and heat transfer through the flask, fall into two basic types, those with and those without a lead liner. Both of these types of flask have circumferential steel fins.

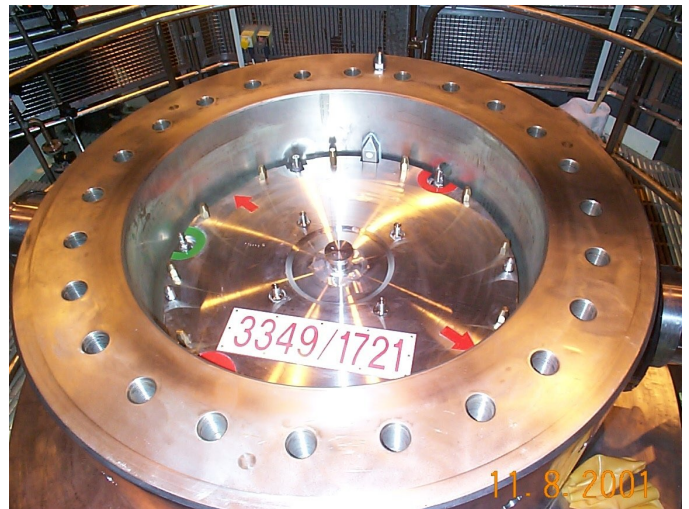
Fig 5 EXL 6 Flask with MEB fitted (no lead liner)

These are commonly called monolithic flasks, for example the EXL6 type, (figs 5), and are manufactured from a one - piece carbon steel body forging of approximately 300mm, clad with stainless steel. A one - piece forged lid is attached to the flask body by means of bolts.

Additional neutron shielding is provided by resin, underneath a carbon steel cladding.

External surface corrosion protection and ease of decontamination is provided by a specially developed paint.

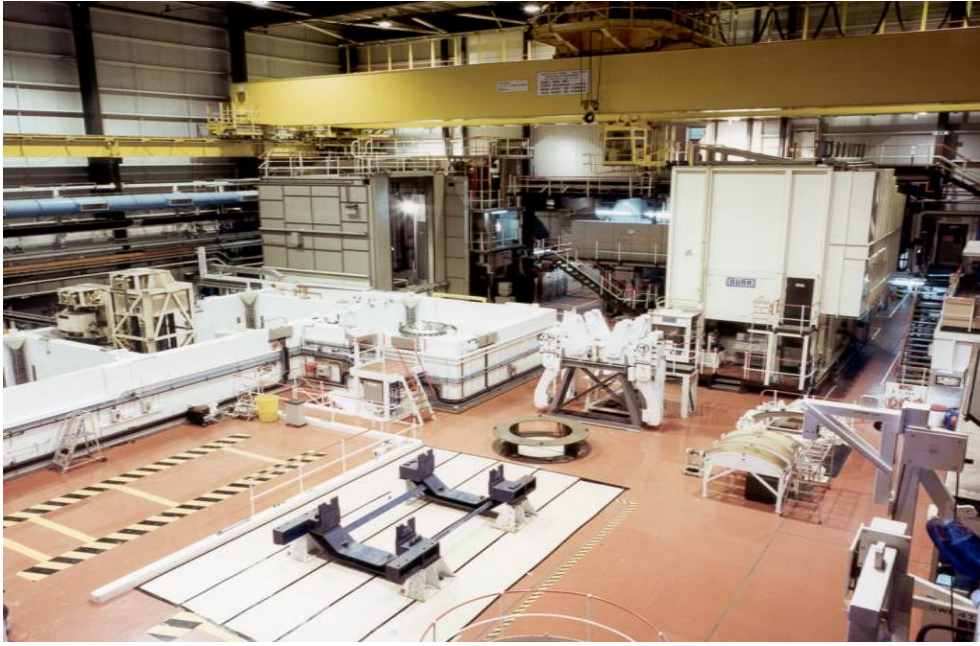
Fig 6 Oxide Flask Maintenance Facility

All the flasks involved in the Japanese Transports and latterly all the European flasks (apart from the NTL15 and NTL9), had their Basic and Major Maintenance performed in the Oxide Flask Maintenance Facility at Sellafield. (Fig 7). (NTL11 flasks were maintained for many years at the Cogema AMEC facility in La Hague).

This was a purpose designed and built maintenance facility for wet type flasks with painted finishes, and was equipped with decontamination areas, grit blast facilities, paint spray booths and rebuild areas.

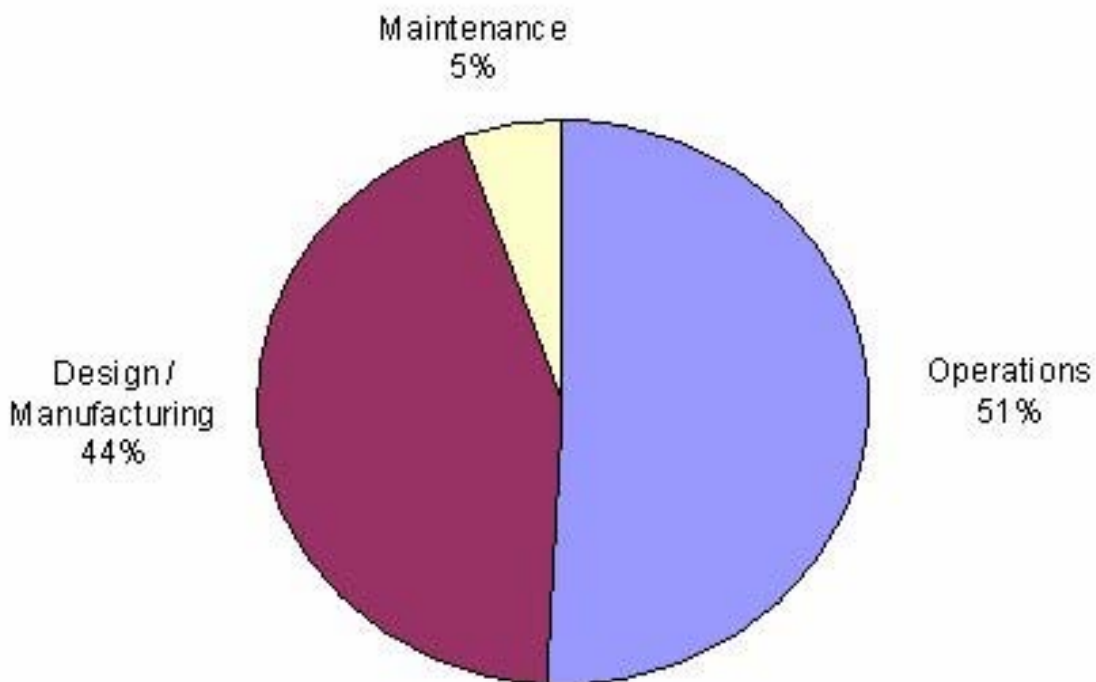
Summary Analysis of Concessions from December 1983 to June 2004

Typical Defects	General Cause	Qty
<ul style="list-style-type: none"> • Handling mechanisms • Tapped holes • Orifice plugs • Location systems (dowels/spigots) • Flask body and major components • Fixing bolts 	Operational Damage	253
<ul style="list-style-type: none"> • Handling mechanisms • Tapped holes • Orifice plugs • Location systems (dowels/spigots) • Flask body and major components • Fixing bolts 	Original Design / Manufacturing non-conformances	220
Flask body and major components	Maintenance error or damage	26

Pictorially this can be represented: -
