Lessons Learned from the Fire Test of Westinghouse's New Type AF Package, the Traveller: (Nothing like the Real Thing)

Westinghouse Electric Company, LLC, Columbia, South Carolina, USA

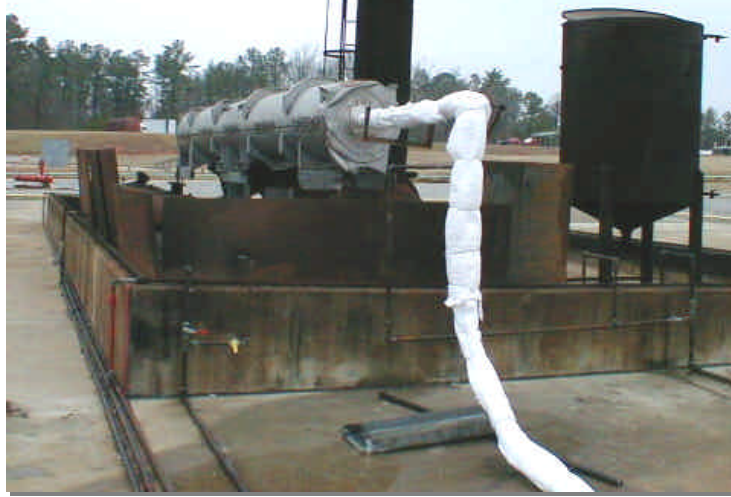
Figure 1 Test Article Before Burn Showing Insulation Wrapped Thermocouple Leads

During the morning, the thermocouple leads were connected to the data acquisition system and laptop computer located approximately 30 ft from the burn pool (Figure 1). The pool was filled with water and fuel flow was started at 12:38 PM. The fuel was ignited at one end at 12:39 and at the other end approximately 30 seconds later. The test was considered to have begun when the test article was completely engulfed in flames. (Figure 2). During most of the burn test, the fuel pumps were off and fuel was allowed to drain by gravity alone into the pool. However, pumps were started at least once to increase fuel flow. Approximately ten minutes into the burn, one of the steel plates on the outside of the pool fell into the pool. This reduced the fire confinement and knocked over the steel structure confining the fuel near the test article. This allowed the fire to spread, resulting in the need to restart the fuel pumps (Figure 3).

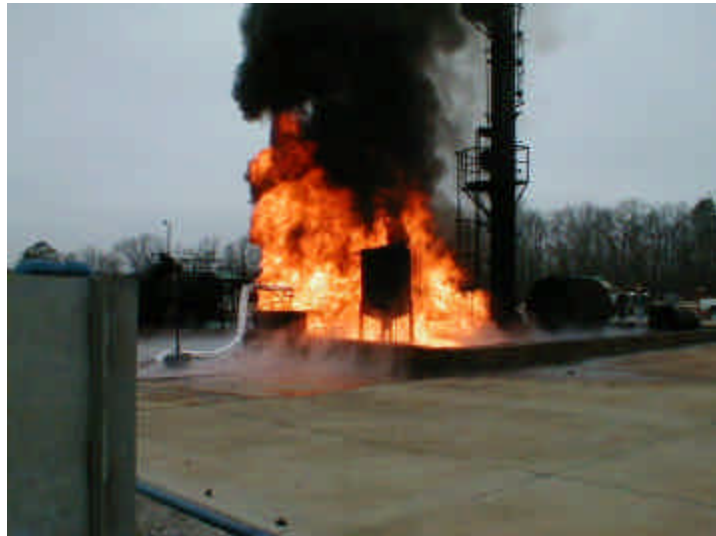
Figure 2 Traveller Burn Test

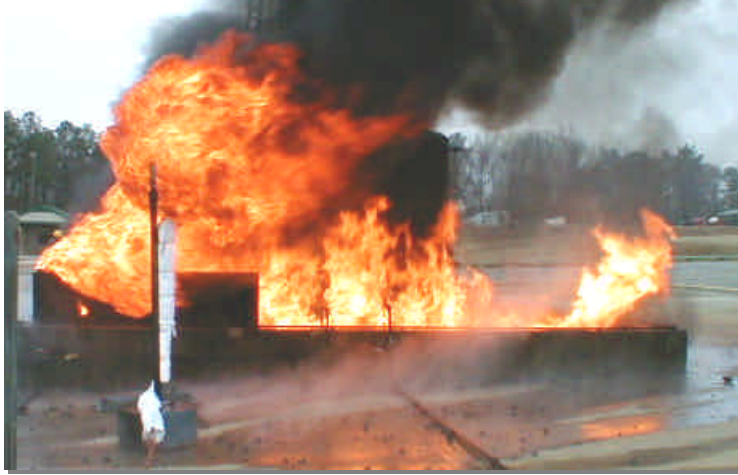
Figure 3 Fire Spread to Rest of Pool

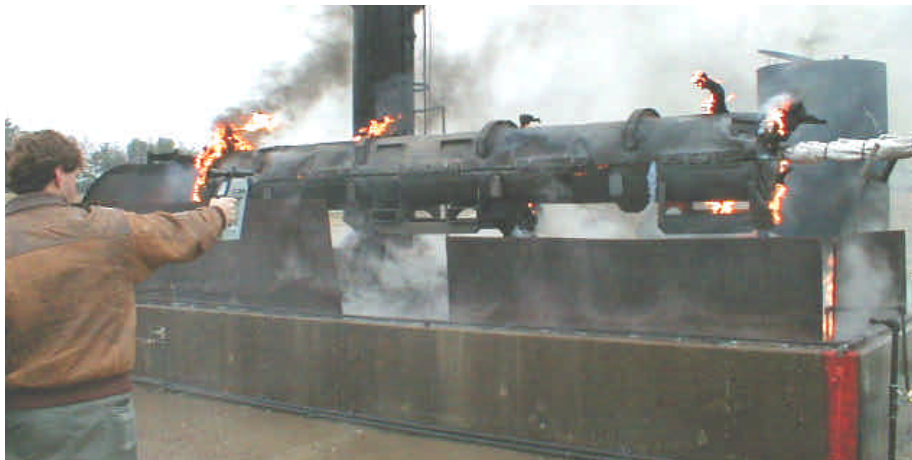
Figure 4 Traveller Prototype After Fire is Extinguished

control valves 33 minutes after the test began. Within approximately 3 minutes, the fire inside the pool was almost completely out. Portions of the urethane foam within the outerpack continued to burn (Figure 4) for another 20 to 30 minutes.

The distorting effects of the fire was seen on the Traveller package as well. Uneven heating from the fire, combined with internal pressure from the burning polyurethane, caused the Traveller outer skin to distort, which caused the top and bottom sections of the outerpack to separate. The outerpack sections had remained closed in the drop tests. The separation between the top and bottom sections provided a path for oxygen into the package. The instrumentation tube also allowed oxygen to enter.

Some of the internal thermocouples were inserted into the polyurethane foam cavity by drilling holes through the inner wall of the Traveller Outerpack. It appears that pressure from the burning polyurethane forced hot gases through at least one of these holes into the package. This ignited the moderator blocks, which burned slowly over the weekend.

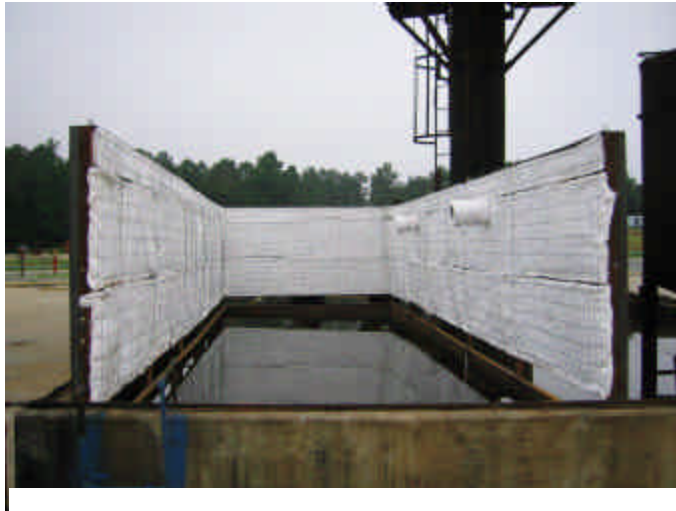
Several months were spent designing and testing burn pool structures that would provide for a steady and even engulfing burn, prevent fuel from escaping, and minimize wind effects. One design was a solid metal wall extending approximately 2-meters above the surface of the pool. This wall incorporated inlet air openings immediately above the pool and was insulated in the fire side by 1.27-cm layer of refractory wool insulation (Figure 5). The back of the steel wall was cooled by radiation/convection. Figure 6 shows this burn wall during testing. The primary problem with the wall was that the interior became significantly hotter than a normal pool fire. Hot gas in the vicinity of the package could not radiate to anything except the flames above it and the hot insulation surface around it. The wall also suffered from heat distortion during testing

Figure 5 Insulated Interior of Burn Wall

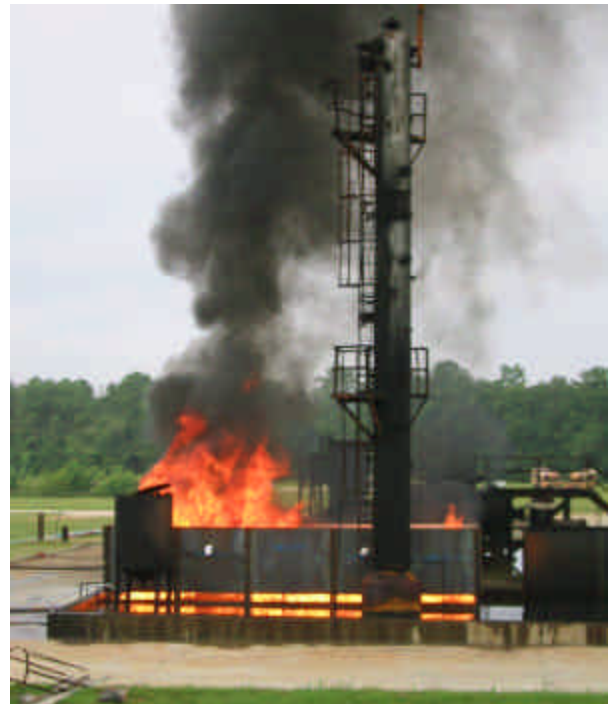
Figure 6 Test Fire Within Wall Structure

The weir structure was modified to use a water-cooled square tube to minimize heat distortion.

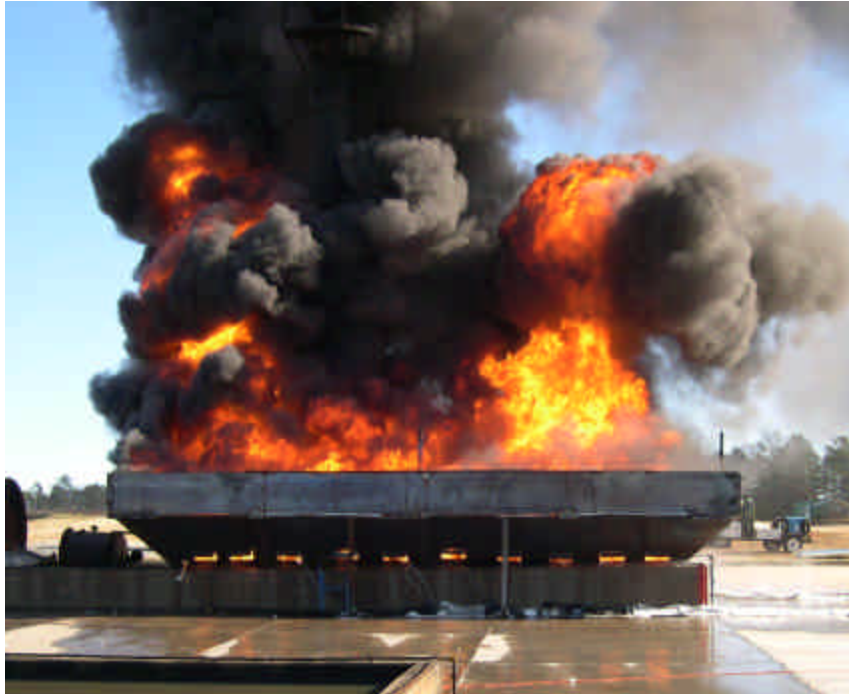
Figure 7 Final Burn Pool Configuration

Above the weir and the concrete pool walls the insulated metal walls were extended outward at 45 degrees to serve as a diffuser to increase the apparent pool size. Finally, the wall rose vertically above the diffuser to extend total height to the top of the package to minimize wind effects. This structure was modified slightly as additional tests were performed, changing the size of air inlet holes, total structure height, and water cooling arrangements. The final configuration is shown in Figure 7.

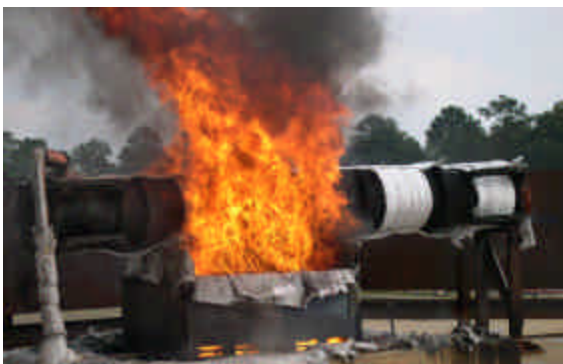
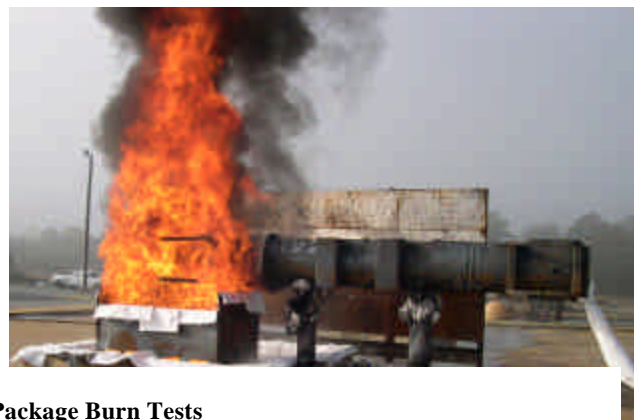
Detailed internal temperature readings were taken in several partial-package burn tests using already burned prototypes. These tests were performed to evaluate different methods of protecting the low temperature components inside the Traveller. Two series of partial-package burn tests were performed. One test subjected a short mid-length of the package to a 30+ minute fire. A second series of tests exposed the end of the package to a 30+ minute fire. These are seen in Figure 9.

Figure 8 Partial Package Burn Tests

Because of the large length-to-diameter ratio of the Traveller and the lower internal conductivity of the outerpack materials, internal response to a partial burn is very similar to the response to a burn engulfing the entire package. Inconel clad instrumentation leads were run out of the burn area where they entered water-cooled tubing to provide additional

protection. These tests showed that the internal temperatures were very close to those predicted by finite element analysis, if the seams remained closed.

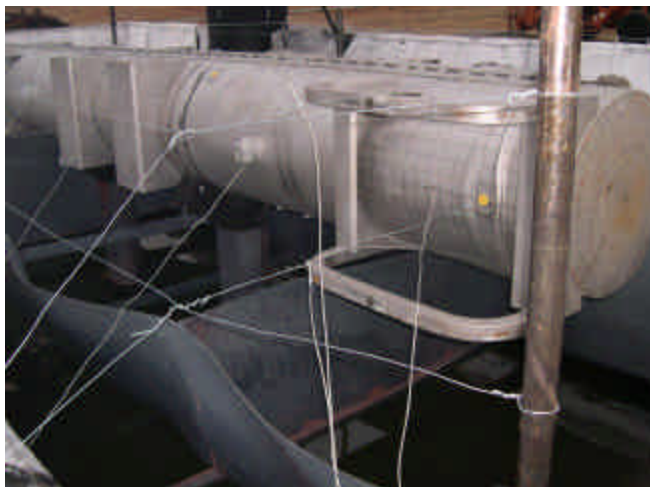
Figure 10 Thermocouples Connected to Outerpack

Temperatures were measured on the outer surface of the outerpack using six type K thermocouples, attached by screws. These thermocouples were located as shown in Figure 10 above. The 30 minute average temperature measured by these thermocouples was 904°C (1659°F). Temperatures inside the outerpack were measured using 13 sets of non-reversible temperature strips, shown in Figure 11. These temperature strips were mounted on the stainless steel covering the moderator blocks, the inside faces of the end-impact limiters, and the inside doors of the clamshell. One set on the stainless steel skin covering the moderator blocks was unreadable. All of the remaining temperature strips on the outerpack lid recorded temperatures of 177°C (351°F) or below.

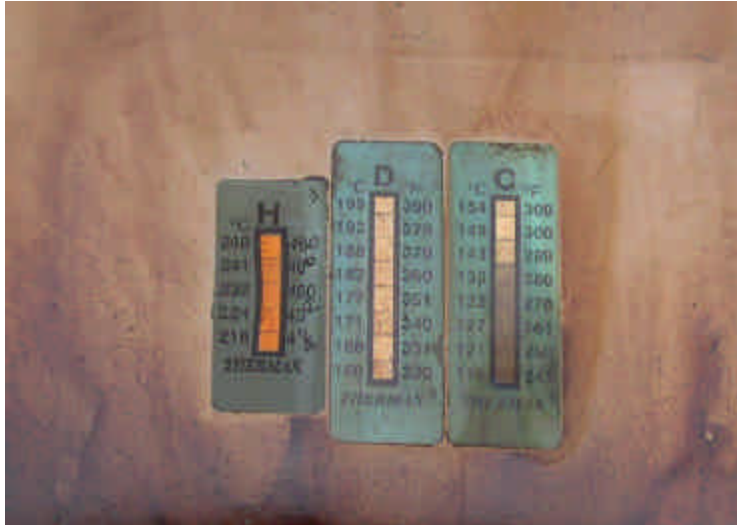
Figure 11 Temperature Strips Inside the Package

top and bottom impact limiters were 116 (241°F) and 149°C (300°F) respectively. Temperatures inside the clamshell were below 104°C (219°F).

Although the outerpack had suffered minor damage from the mechanical tests that allowed some urethane decomposition products to escape into the package interior, the fuel assembly, clamshell, and polyethylene moderator blocks survived the fire essentially undamaged.
