Early Thermal Testing of Type B Radioactive Material Packages in the US to Environments beyond the Regulatory Package Thermal Test Standards

ABSTRACT

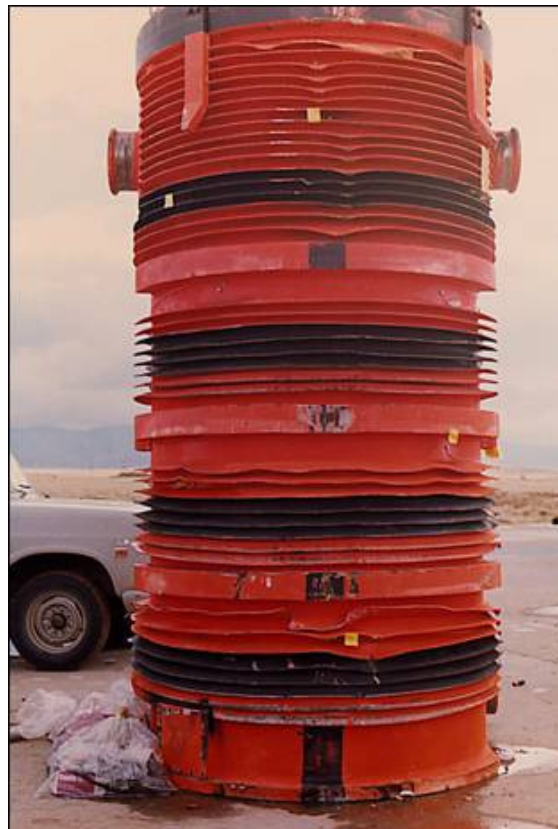
The cask, which is shown photographically prior to the fire test in Figure 1, had previously been impacted in its transport railcar into a massive barrier at 131 km/h (81 mph) ^[3]. As can be seen from Figure 1, the cask sustained only “cosmetic” damage as a result of this dynamic structural test; there was only minor bending of the external heat transfer fins.

Fig. 1. Photograph of the obsolete 67-tonne cask prior to fire test.

The obsolete 67-tonne SNF cask, which was designed in the late 1950s and was fabricated in 1962, was of steel/lead construction. It was a stainless steel, double-walled, lead-shielded cylindrical vessel 3.96 m in length and 1.5 m in diameter. The lead was contained in a the cylinder between the two stainless steel shells, where the combination of stainless steel and lead provided gamma-shielding of the radiation emanating from the SNF. This early-designed cask utilized an auxiliary water cooling system of stainless steel channels welded to the outside of the inner shell of the cask body. The cooling system was provided, not for safety purposes, but for facilitating rapid handling of the cask and its contents after shipment. Also, copper fins were welded to the inside of the outer shell to facilitate heat transfer from the lead to the outer shell.

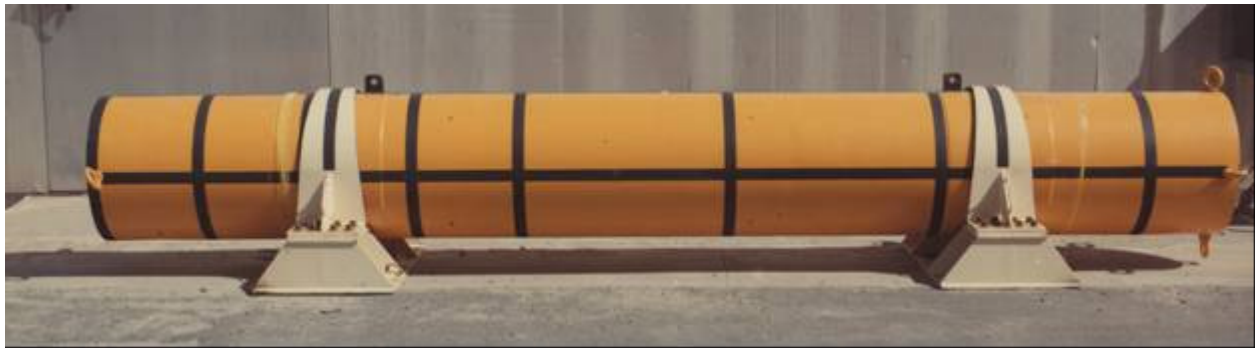
The cask tested is shown photographically in Figure 2 and schematically in Figure 3.

Fig. 2. Photograph of the PNC SNM cask and a schematic of its design.

The cask sustained only minor structural damage during the series of mechanical tests that preceded the thermal test. The cask design consisted of thin concentric steel shells; the annular spaces were filled with balsa wood. Although the cask had sustained some deformation [up to approximately 5 cm (2 in) deep], the inner lid and seals were still intact. The cask was relocated into the tested trailer for the thermal test.

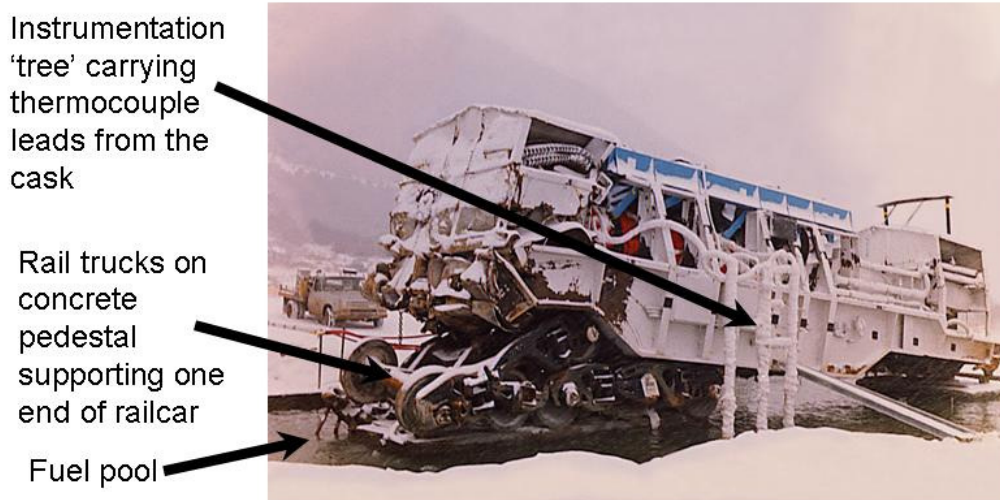
pool, supported on concrete pedestals. The cask/railcar and the wheel trucks that had become disengaged during the preceding impact test were positioned as they had been following the impact with the barrier as shown in Figure 5. Extensive thermocouple monitoring of the flame and the cask was undertaken during the test. The thermal-shielded “trees” for the thermocouples leading from the edge of the pool into the cask can be seen in Figure 5.

Fig. 5. Cask/railcar assembled over fuel pool prior to testing.

The fuel pool was constructed specifically for this test. It measured 0.9-m deep, 9.1-m wide and 18.3-m long. JP-4 (jet) fuel was continuously piped into the pool to maintain a 15-cm layer of fuel above 60-cm of water. The cask/railcar combination was reassembled over the large fuel

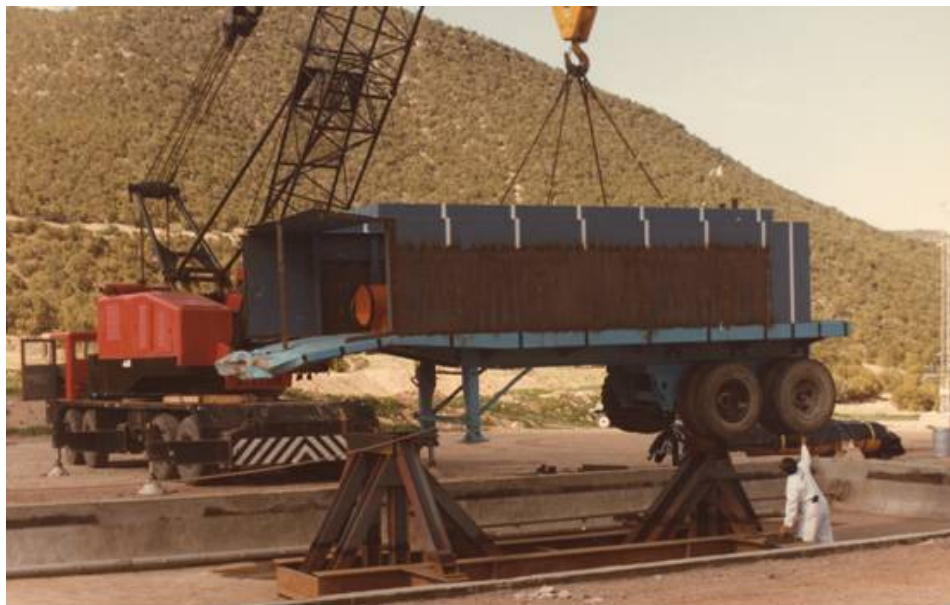
The fuel pool that had been used for the railcar/cask pool fire test described above was also used for the truck/cask pool fire test. The casks that – as described previously – had been exposed to the structural tests were relocated into the tested trailer, and cask/trailer system was then positioned over the fuel pool as shown in Figure 6, for the thermal test.

Fig. 6. Placement of SNM cask in tested trailer over fuel pool.

The trailer included the sides and the top of 0.8 cm (0.31 in) thick mild steel plating; however, because the front end of the trailer was severely damaged in the impact test, it was fully removed for the thermal test. One tear occurred in the trailer deck during the impact test, which showed a weakness in the design and the design was corrected for actual use to prevent such damage from happening in an actual accident. Therefore the tear in the deck was repaired prior to the thermal test.

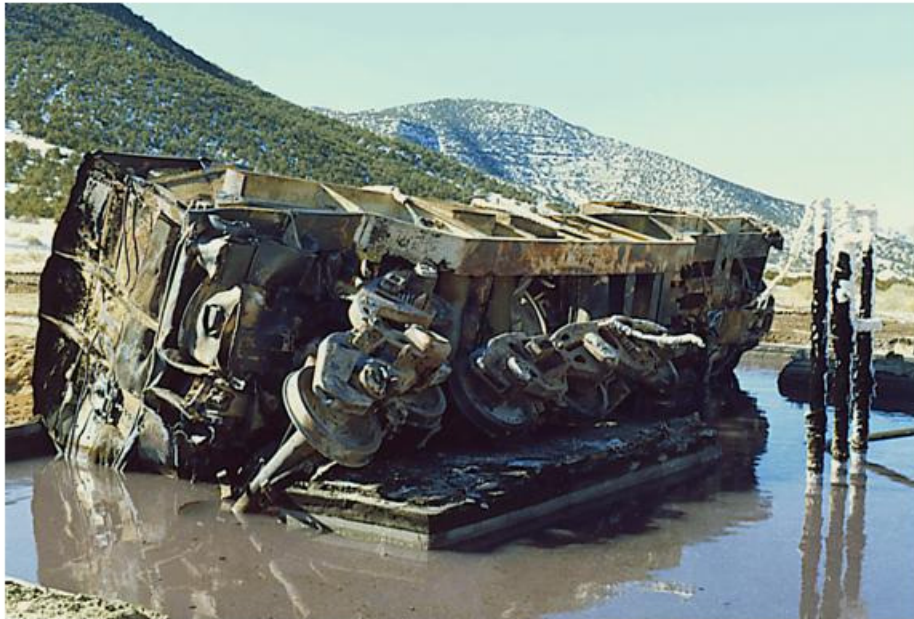
During approximately the first 90 minutes of the test, the cask temperature response followed a relatively mild response, following which the rate of temperature rise increased more rapidly. At approximately 100 minutes, a white cloud of smoke was visually detected emanating from the cask. At this time the supply of fuel to the pool was terminated, but the fire continued to burn until all fuel was consumed. Due to the weakening of the concrete and metal supports and the metal railcar, the railcar still containing the cask toppled onto its side at approximately 122 minutes, severing all thermocouple connections. The fire self-extinguished at 125 minutes. The final position of the railcar/cask following fire exposure is shown in Figure 8.

Fig. 8. Cask/Railcar following exposure to fire for 125 minutes.

A thorough post-mortem inspection of the tested cask was undertaken ^[13] to assess the modes of failure resulting from this extensive thermal exposure. This detailed disassembly and metallurgical analysis of the cask showed *“the presence of two macrofissures in the outer cask shell. The first, lying within a stainless steel seam weld fusion zone, is believed to be a hot crack which resulted from elevated temperature stressing of the cask. The second crack, located within the stainless steel base metal, appears to originate at a copper-stainless steel dissimilar metal weld joint during manufacture, with final propagation thru the outer cask shell occurring during the fire-exposure.”*

It is noteworthy that the cask was initially designed to incorporate empty volumes next to the lead shield to accommodate lead expansion should it melt. However, the post-mortem examination showed that the pathways from the lead gamma-shield to the expansion volumes were not opened during fabrication. Based on this finding, Reference [13] concluded that *“neither macrofissure would have formed if (a) the fire test temperature had not been excessive, that is exceeding the Nuclear Regulatory Commission (1075°K – 30 min.) regulation, (b) appropriate lead expansion volumes had been provided, and (c) appropriate procedures, e.g., a Ni filler wire and low heat input, had been used during welding of the copper fins to the stainless steel outer wall”*. Thus, with the advance in metallurgical technology and the imposition through regulations of more stringent quality assurance during fabrication, the problems encountered after the obsolete 67-tonne cask had been exposed to the fully engulfing fire for about 90 minutes could have been avoided.

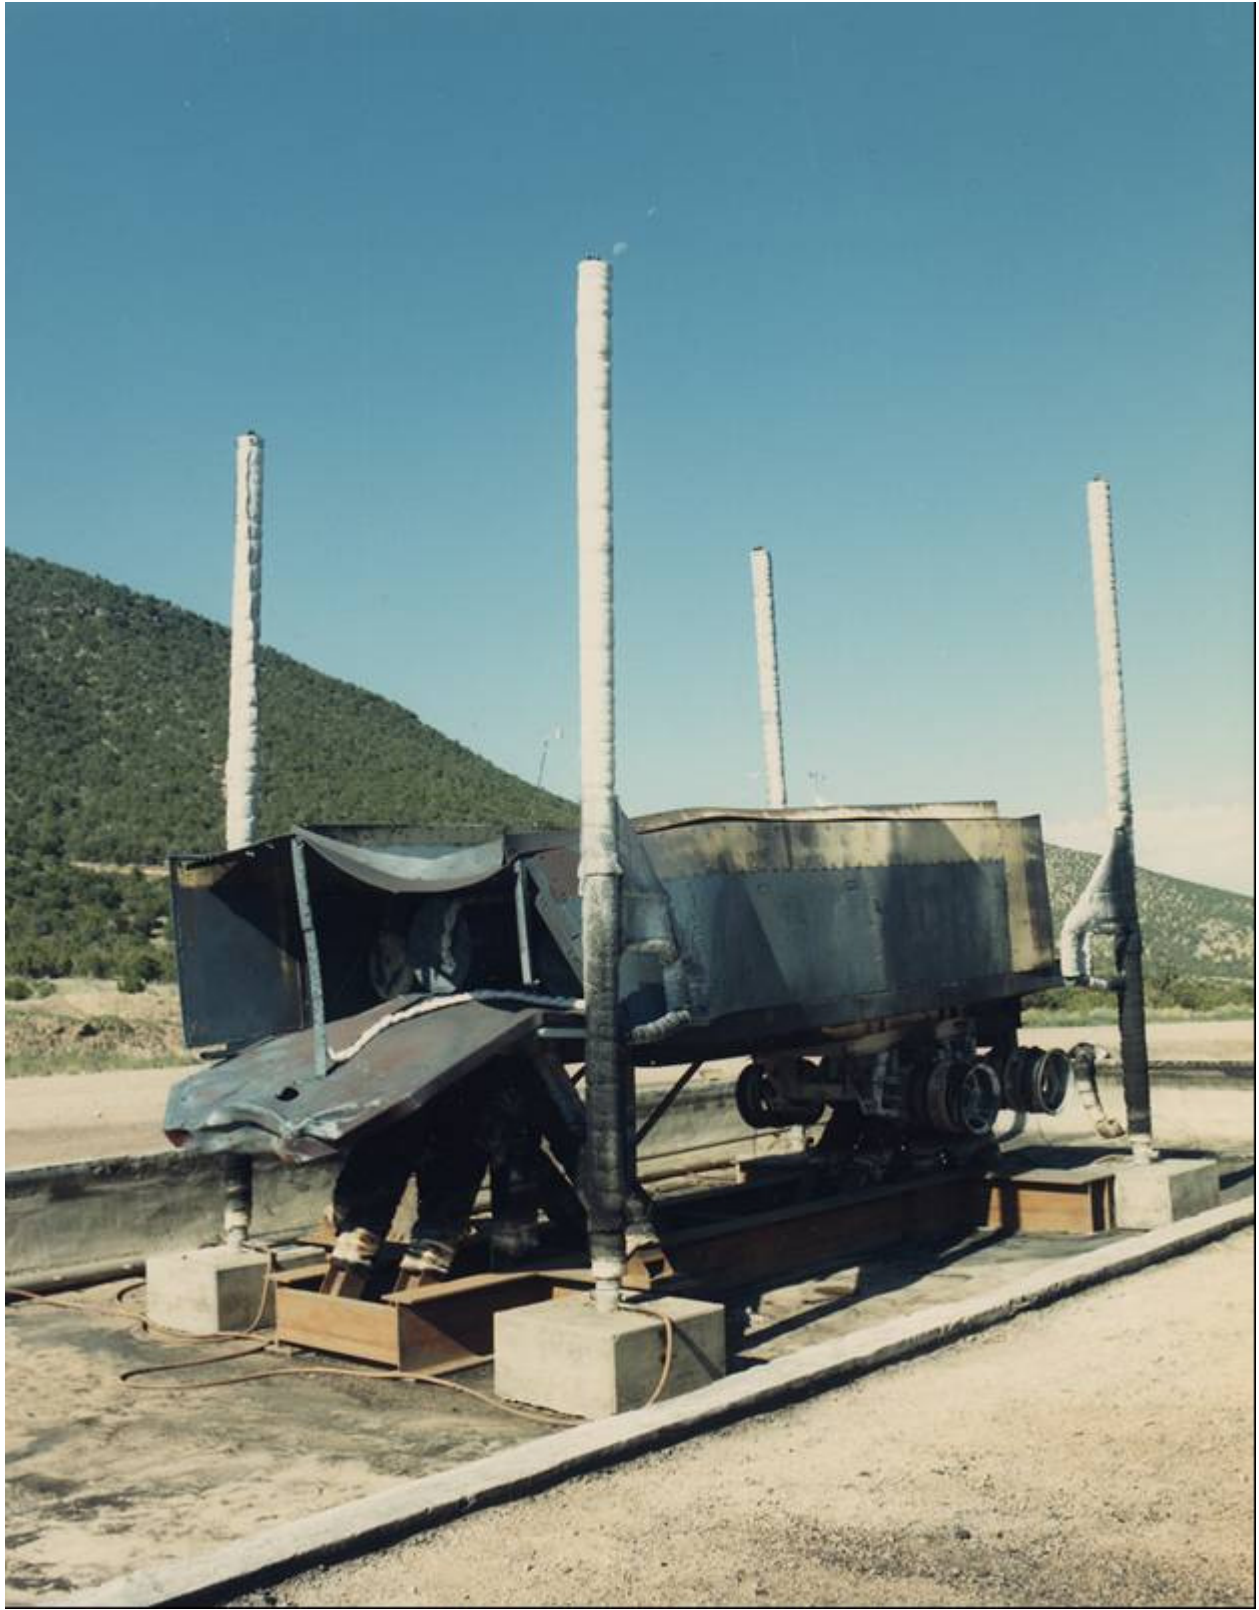
The time for performing the test was selected to provide as near-optimal weather conditions as possible. The velocity varied from 0 to no more than 8 km/h (5 mph). Once the fuel was ignited, flames quickly engulfed the trailer/cask system. A study of the films of the test showed that, during the 72 minutes of the fire, the system was totally engulfed for 69 minutes (i.e. for 96 percent of the time). The tested system, following termination of the fire exposure is shown in the photograph provided in Figure 10.

Fig. 10. Photograph of cask/trailer system following fire exposure.

The cask was examined in detail following exposure to the fire test. It was not possible to remove the outer head of the cask after the thermal test because of structural damage incurred during the preceding impact tests. Thus, the examination included leak rate testing of the seals and physically sectioning the package for visual examination. The results of the examination are as follows:

- (a) The post-fire leak rate test exhibited no detectable leak;
- (b) Temperature sensitive labels on the inner head showed maximum temperatures of only 205°C to 210°C;

- (c) Much of the balsa wood was charred (approximately 90 percent on the upper half and 70 percent in the lower half, with some local areas having been completely charred);
- (d) The maximum surface temperatures of the cask exceeded 600°C, and were thus well above the temperatures measured on the inner head (slightly above 200°C). Thus, the charring of the balsa wood can be viewed as a thermal protective mechanism, creating a low-conductivity porous structure that limited the heat transfer to the cask interior; and
- (e) Since the temperatures at the front of the cask where the trailer was open to the fire were higher than those at the rear of the cask where the trailer walls were intact, it was concluded that the intervening structure of the trailer served as an effective thermal shield.

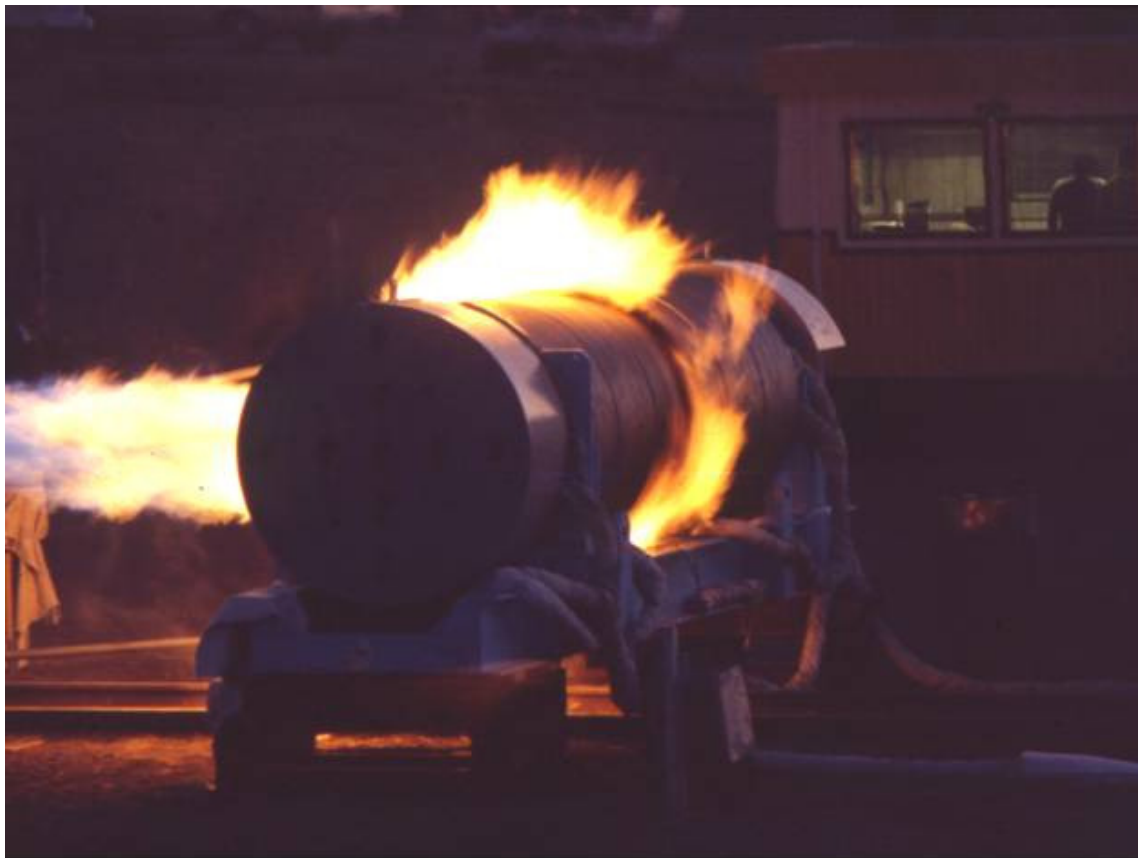
A photograph of one of the torch tests is shown in Figure 11.

Fig. 11. Photograph of modified HNPF cask being exposed to torch environment at the side of the cask in the centre.

For the torch tests of the modified HNPF cask, the response at various locations was monitored, and the maximum temperatures in these locations was determined. Table 2 summarizes those results. The temperatures reported in this table are:

The table shows that each test was initiated with a different starting temperature in the cask cavity, ranging from 9 °C to 31 °C. This resulted from changes in the ambient conditions during the test program, and residual heat in the cask from preceding tests. These data show that exposure to the torch environment does not significantly threaten the containment system.
