## ROADRUNNER CONTAINMENT SEAL DAMAGE INVESTIGATION – OPERATING EXPERIENCE

### ABSTRACT

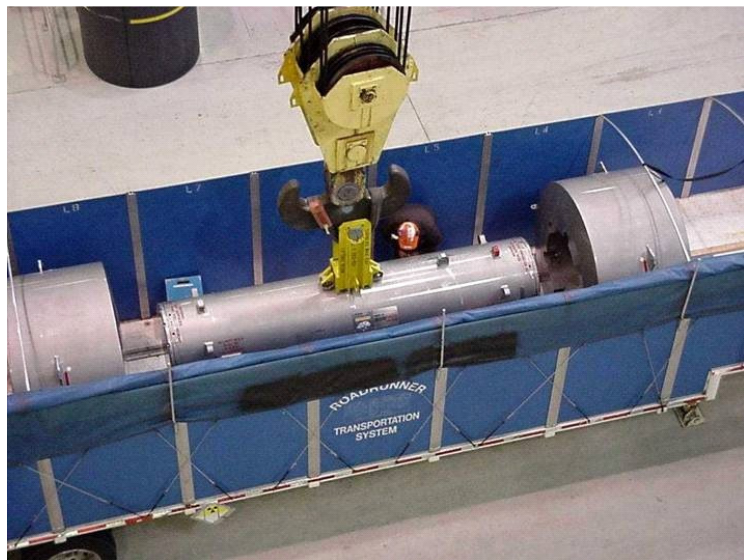
**Figure 1: Roadrunner Transportation Package**

The lessons learned from the 2005 Roadrunner incident investigation were applied to many aspects of the OPG radioactive materials transportation program and have led to a stronger program with improved operating procedures, training, supervision and attention to procedural and regulatory compliance. The Roadrunner with the impact limiters retracted in preparation for unloading is shown in Figure 1.

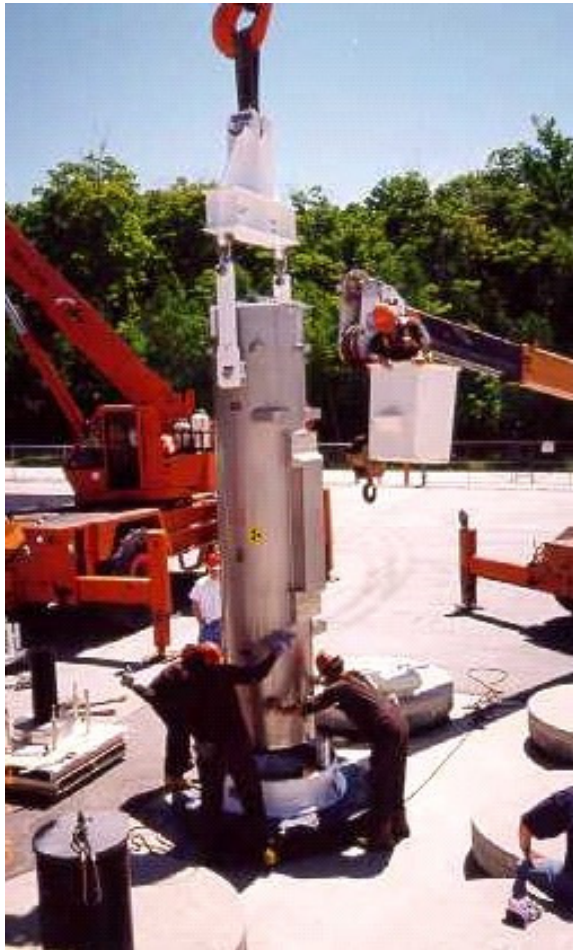
**Figure 4: Unloading of the Roadrunner Transportation Package**

removed. For vertical unloading, a cable is attached to the payload via the “B” end access port, the package is rotated to the vertical orientation, mated with the in-ground storage container, and the payload is lowered out of the package into the storage location. A photo of a vertical unloading operation of the package is shown in Figure 4.

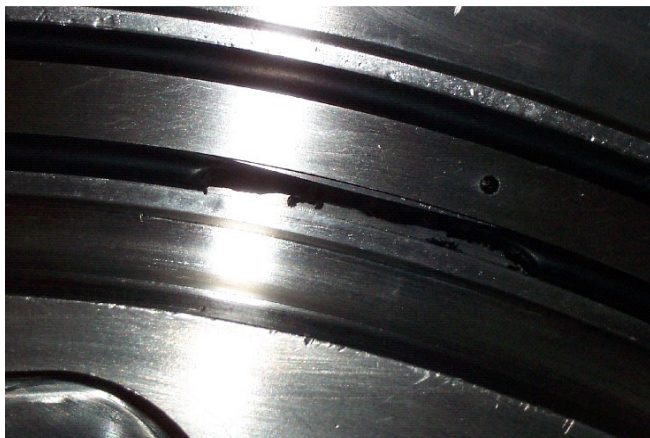
**Figure 5: Damaged O-Ring in Groove**

In 2005 a damaged containment o-ring was discovered when the “B” end containment plate was removed in preparation for unloading the Roadrunner. Details of the damage are shown in Figure 5 and Figure 6. No contamination was detected by surveys of the adjacent areas on the package, the corresponding impact limiter or on the transport trailer. The containment plate was re-installed on the package and an air pressure decay test was performed. The test was unsuccessful - the damaged containment seal could not retain pressure. It was concluded that the shipment had been made with a non-functional containment seal.

- **Damage.** The probable cause of damage to the o-ring was mechanical. It is suspected that a portion of the o-ring was inadvertently dislodged from its groove after a previous shipment had been unloaded, and was sheared or cut by the containment plate during re-installation.

- Revise operating procedures to clearly and explicitly identify critical aspects (containment integrity, testing and safety) of package handling.
- Review and revise operating procedures for consistency and confirm that the specified tasks are compliant with the package safety analysis report and the Certificate for Transport Package Design.
- Review and revise maintenance and unloading procedures to require air pressure decay tests after re-assembly to verify package containment integrity prior to next use.
