ACCELERATED CORROSION TESTING OF ALUMINUM BORON CARBIDE METAL MATRIX COMPOSITE IN SIMULATED PWR SPENT FUEL POOL SOLUTION

MAXUS[®]

- Newly developed in NLM
- Al/B₄C MMC Plate
- Neutron-absorbing material
- For both dry storage casks and wet storage racks

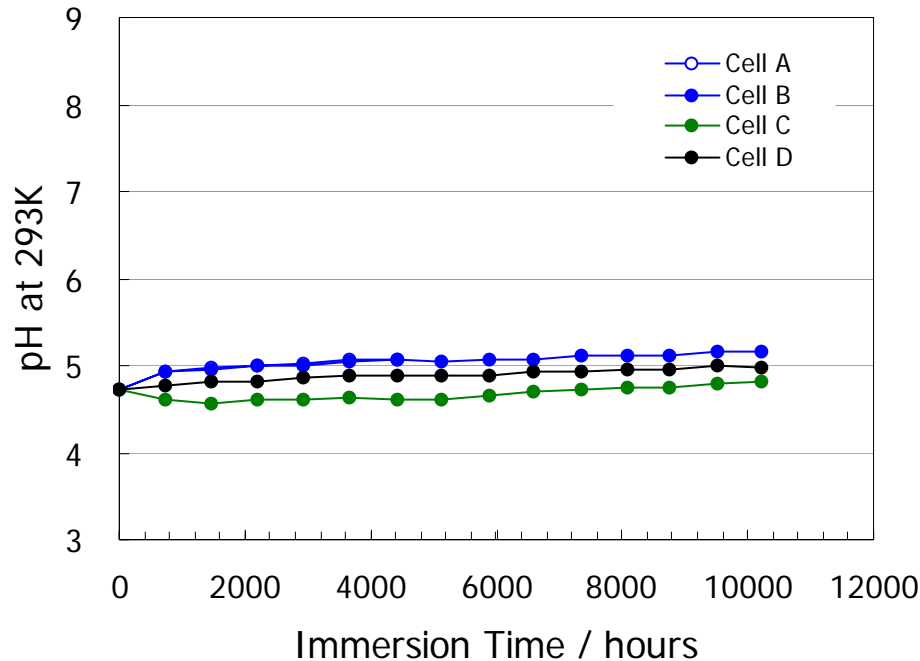
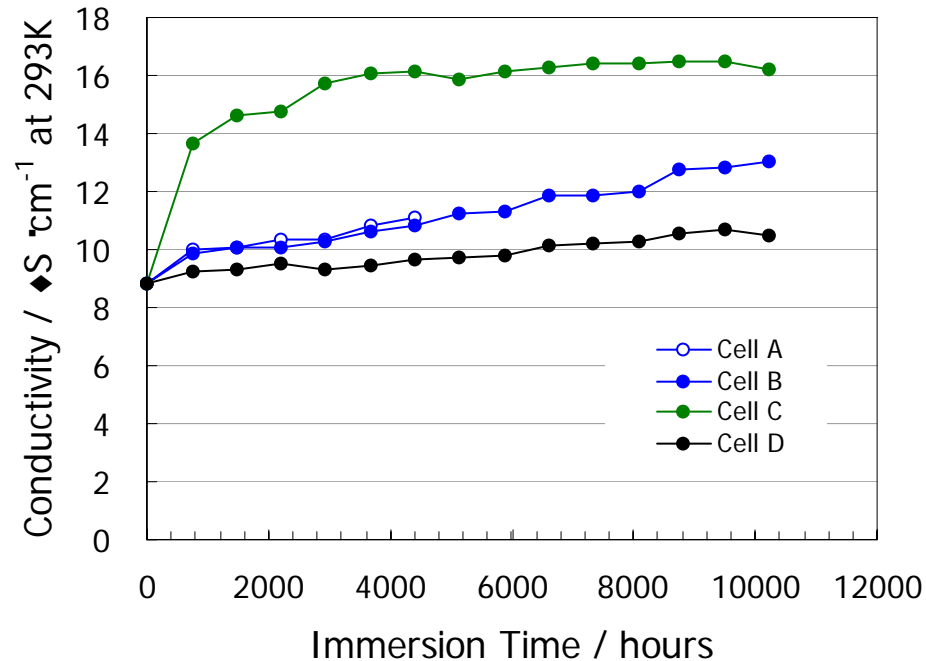
Conductivity and pH of the Bath

- The pH hardly changed though the conductivity increased a little.
- Sulfuric acid ion was detected from the bath in cell C, and there is a high possibility that this sulfuric ion dissolved from anodic films caused the increase of the conductivity.

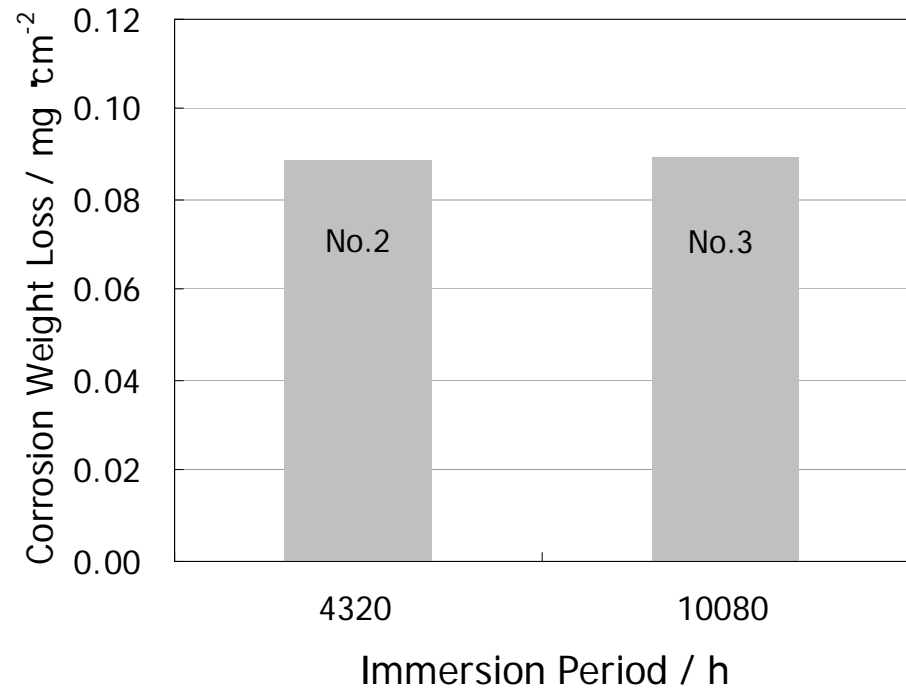
Dry Weight Change and Corrosion Weight Loss

Coupon No.1 ~4 (non-Anodized)

- Because there is no difference between 4,320 hours and 10,080 hours in these values, it can be considered that the hydration reaction with solution has stopped after 4,320 hours.
- The corrosion weight loss is about 0.09 mg/cm², it corresponds to the dissolution of 0.6 μm as aluminum metal. Therefore it is not considered to be significant for practical use.

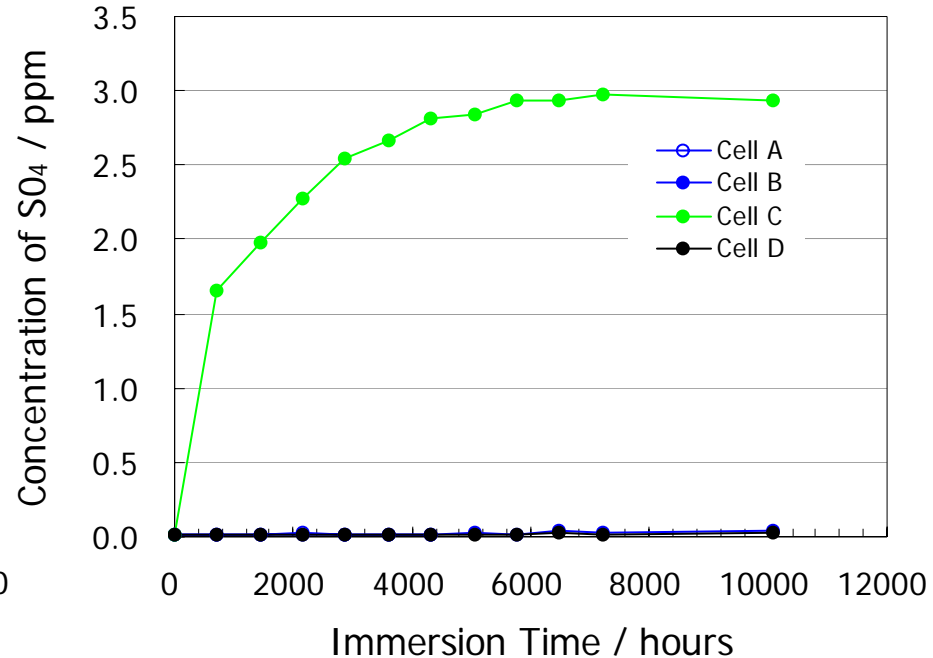
Conductivity and Concentration of SO_4^{2-} of the Bath

- Sulfuric acid ion was detected from the bath in cell C, and there is a high possibility that this sulfuric ion dissolved from anodic films caused the increase of the conductivity.
