# Crush Testing at Oak Ridge National Laboratory

Matt R. Feldman  
Oak Ridge National Laboratory  
Oak Ridge, Tennessee, 37831-6472, U.S.A.

The dynamic crush test is required in the certification testing of some small Type B transportation packages. International Atomic Energy Agency regulations state that the test article must be “subjected to a dynamic crush test by positioning the specimen on the target so as to suffer maximum damage.” Oak Ridge National Laboratory (ORNL) Transportation Technologies Group performs testing of Type B transportation packages, including the crush test, at the National Transportation Research Center in Knoxville, Tennessee (United States). This paper documents ORNL’s experiences performing crush tests on several different Type B packages.

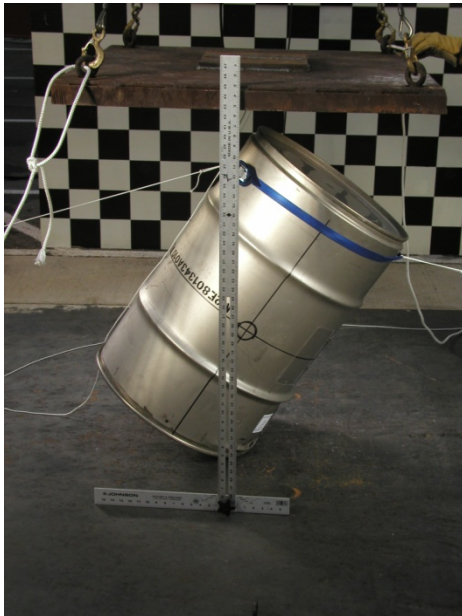
**Figure 1. The CG of the crush plate is aligned with the CG of ES-2100 TU-3 before crush testing.**

The ES-2100 shipping package, designed by the Y-12 National Security Complex, was exposed to the crush test in December of 2002. A very similar package design (ES-2) had undergone HAC testing before adoption of the crush test in the United States. The tests in 2002 were to prove the package’s design worthiness and to ensure its ability to be used internationally. Four test units (TUs) were subjected to crush testing, two to the crush test stipulated in the U.S. regulations, and two to the crush test as described in IAEA ST-1.<sup>[4]</sup> A tabular description of the tests performed is provided in Table 1. Preparations for crush testing ES-2100 TU 3 (TU-3) are shown in Figure 1, and the resulting damage from that crush test is shown in Figure 2.

In an attempt to cause maximum damage during these tests, the center of gravity (CG) of the plate was always lined up through the CG of the TU. Theoretically, this alignment represents maximum transfer of energy from the plate to the TU. The crush test caused far greater deformation of the outer drum in the ES-2100 than did the 9 m drop test. TUs 3 and 4 showed greater damage after being crush tested than TUs 1 and 2 did after the 9 m drop test. When TUs 1 and 2 were subsequently exposed to the

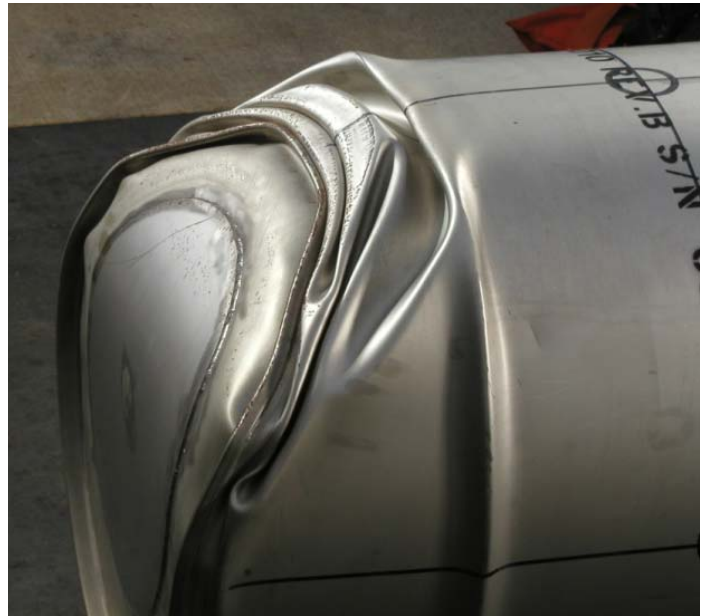
**Figure 2. Crush test damage to ES-2100 TU-3.**

crush test, their overall deformation was only slightly worse after both the 9 m drop and crush tests than TUs 3 and 4, which had only undergone the crush test. All four TUs were subsequently exposed to both the HAC puncture and HAC thermal tests. After HAC testing was complete, all four units passed operational leak tests.

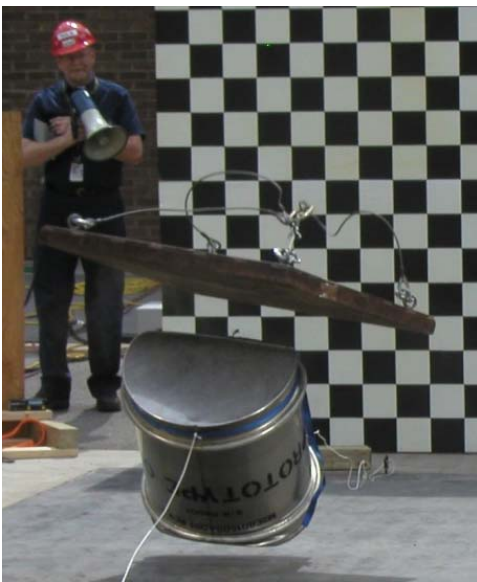
**Figure 3. DPP-2 TU-2 recoils off of the drop pad in response to initial impact of crush plate.**

The DPP-2 shipping package, designed by the Y-12 National Security Complex, was exposed to the crush test in July of 2003 during certification testing of the package design. Six DPP-2 TUs were subjected to the crush test. As with the ES-2100, the CG of the crush plate was aligned through the CG of the DPP-2 TU for every crush test performed. A tabular description of the tests performed is provided in Table 2. A picture of the crush testing of DPP-2 TU-2 is shown in Figure 3, and damage to DPP-2 TU-6 from the crush test is shown in Figure 4.

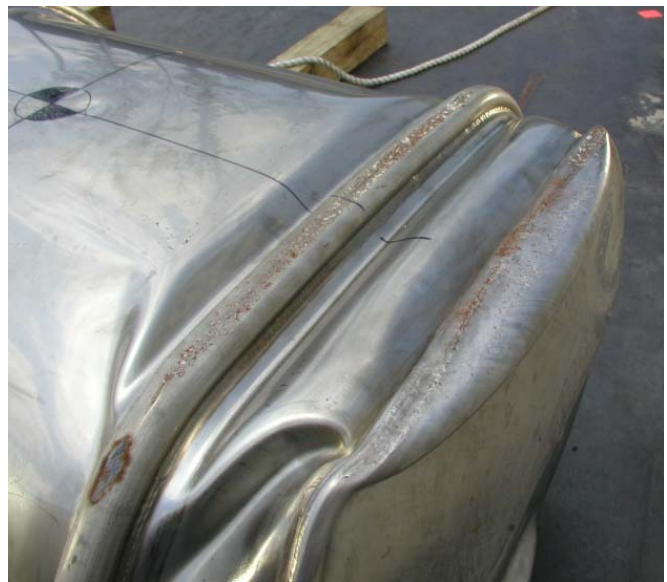
**Figure 4. Crush test damage to DPP-2 TU-6.**

As with the ES-2100, the CG of the plate was always in alignment with the CG of the TU. Again, the crush test caused far greater deformation to the outer drum than did the 9 m drop test when the DPP-2 package design was tested. The DPP-2 package design included two crush-resistant hoops welded to the outside of the packaging's drum. These hoops appeared to help limit crush test damage but did not prevent it. All six TUs were subsequently exposed to both the HAC puncture and HAC thermal tests. After testing was complete all six units passed helium leakage tests, indicating they were "leaktight" units.

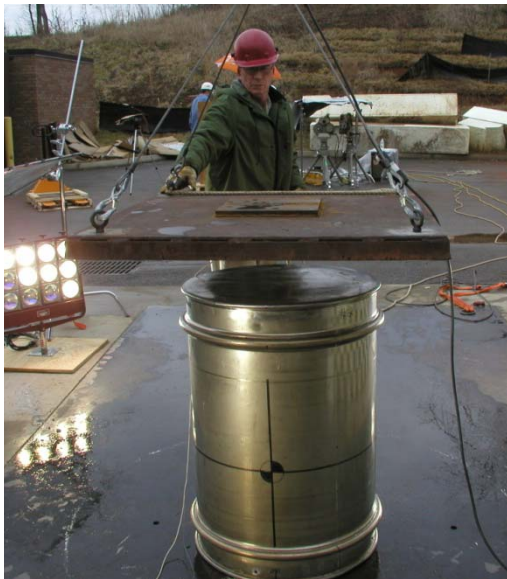
**Figure 5. The crush plate is centered over MD-1 TU-4 before crush testing.**

The MD-1 shipping package, designed by the Y-12 National Security Complex, was exposed to the crush test in February of 2004 during certification testing of the package design. Five MD-1 TUs were subjected to the crush test. A tabular description of the tests performed is provided in Table 3. Preparations for crush testing MD-1 TU-4 are shown in Figure 5, and the resulting damage from that crush test is shown in Figure 6.

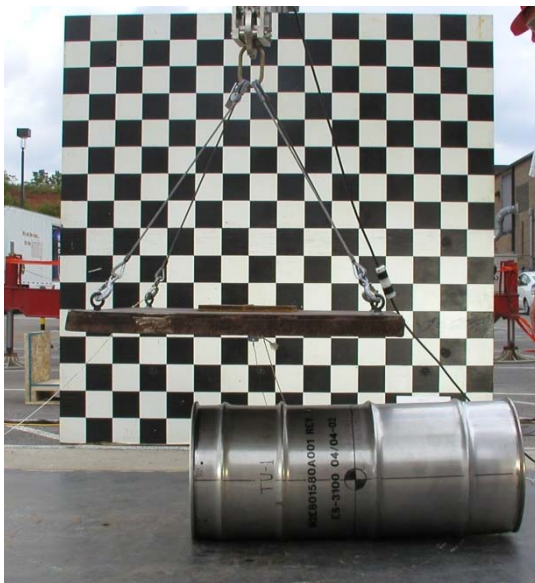
**Figure 7. The crush plate is centered over the CV flange of ES-3100 TU-1.**

Preparations for ES-2100 TU-1 crush testing are shown in Figure 7, and the resulting damage from that crush test is shown in Figure 8.

For TU-1, the CG of the crush plate was aligned with the CV flange. For all other crush tests (TU-2 through TU-5), the CG of the plate was aligned with the CG of the TU. Again, the crush test caused far greater deformation to the outer drum than did the 9 m drop test when the ES-3100 package design was tested. All five TUs were subsequently exposed to both the HAC puncture and HAC thermal tests. After testing was complete, all five units passed helium leakage tests, indicating they were “leaktight” units.

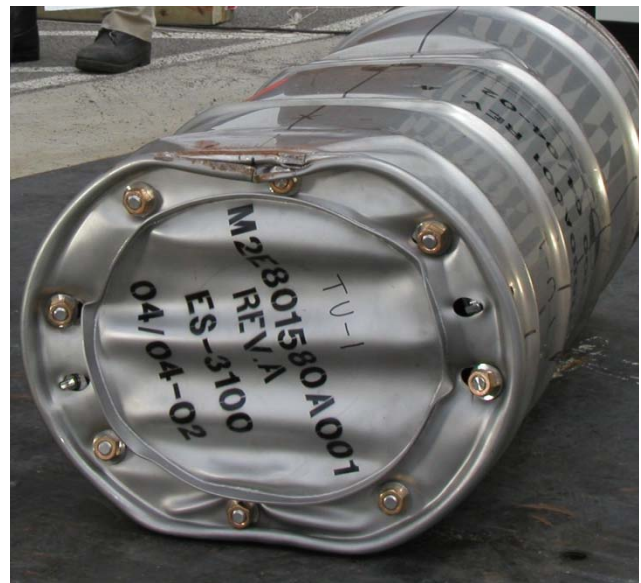
**Figure 8. Cumulative 9 m drop and crush test damage to ES-3100 TU-1.**

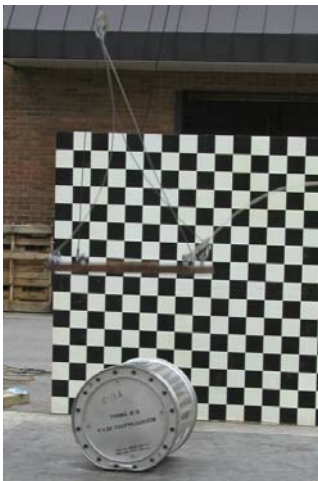
**Figure 9. The crush plate just before impact with MD-2 TU-3.**

subjected to the crush test. A tabular description of the tests performed is provided in Table 5. A picture of MD-2 TU-3 crush testing is shown in Figure 9, and damage to the MD-2 TU-1 drum weld seam from the crush test is shown in Figure 10.

Four of the MD-2 TUs were tested with the CG of the plate aligned somewhere other than the CG of the package. For TUs 2, 5, and 8, the CG of the plate was aligned through the flange of the CV, and for TU-3, the CG of the plate was aligned through the upper weld seam on the CV. As with previously tested package designs, the crush test caused far greater deformation to the outer drum than did the 9 m drop test when the MD-2 package design was tested. All six TUs were subsequently exposed to both the HAC puncture and HAC thermal tests. After testing was complete, all six units passed helium leakage tests, indicating they were “leaktight” units.

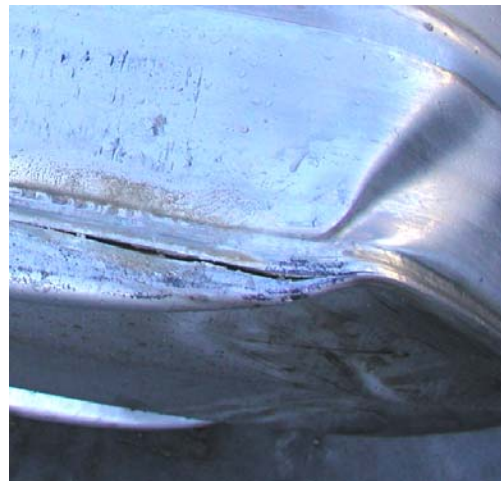
**Figure 10. Split drum weld seam on MD-2 TU-1 after crush test.**
