**Paper No. 2048      Development of a Benchmark Series  
of Cask Drops for Validation of Explicit  
Dynamic Finite Element Analyses**

**Douglas J. Ammerman**

Sandia National Laboratories<sup>1</sup>, Albuquerque, NM, USA

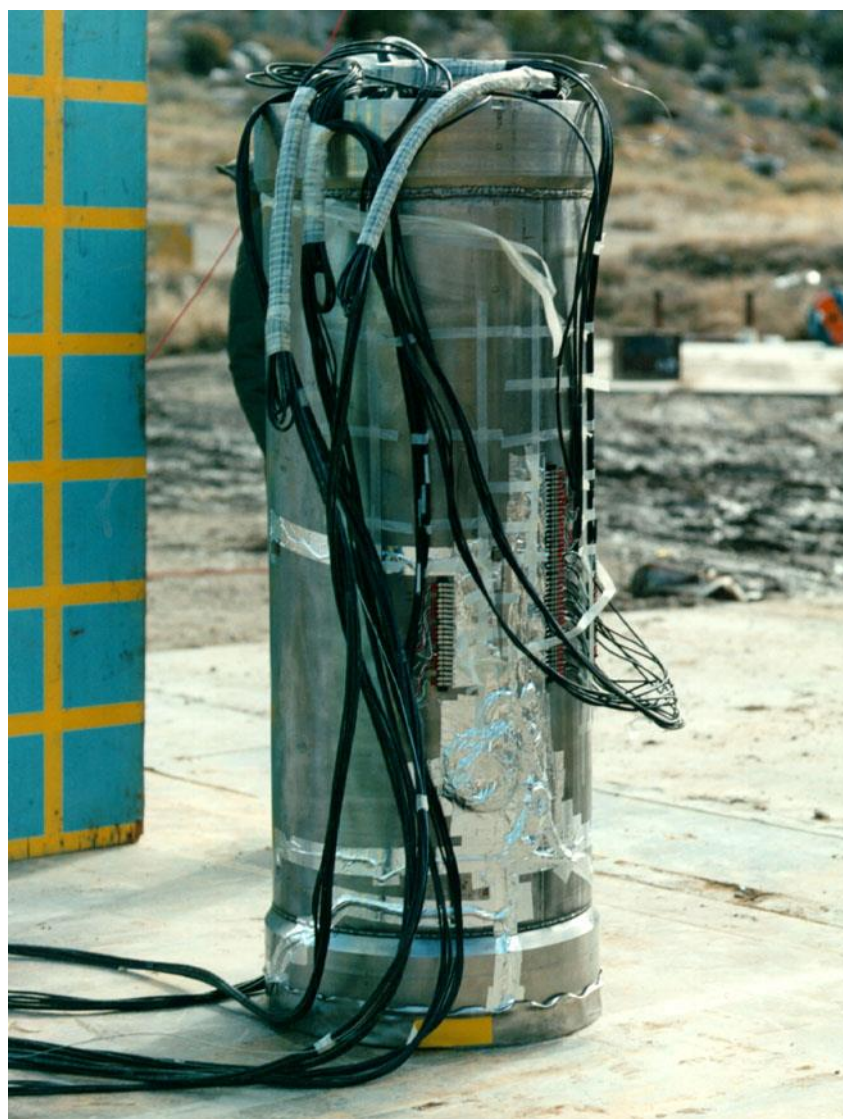
**Figure 4 – Deformed shape from the 9-meter drop**

The deformed shape of the SETU following the 9-meter end impact is shown in Figure 4. This impact was very nearly perfectly axial, and the only visible sign of damage is the partially crushed impact limiter. Table 1 shows an example of the dimensional inspection data of the cask body lengths (L1 and L2 from Figure 3). In addition to this data, the amount of crush of the impact limiter was measured as 1.4 inches. Figure 5 shows typical acceleration results.

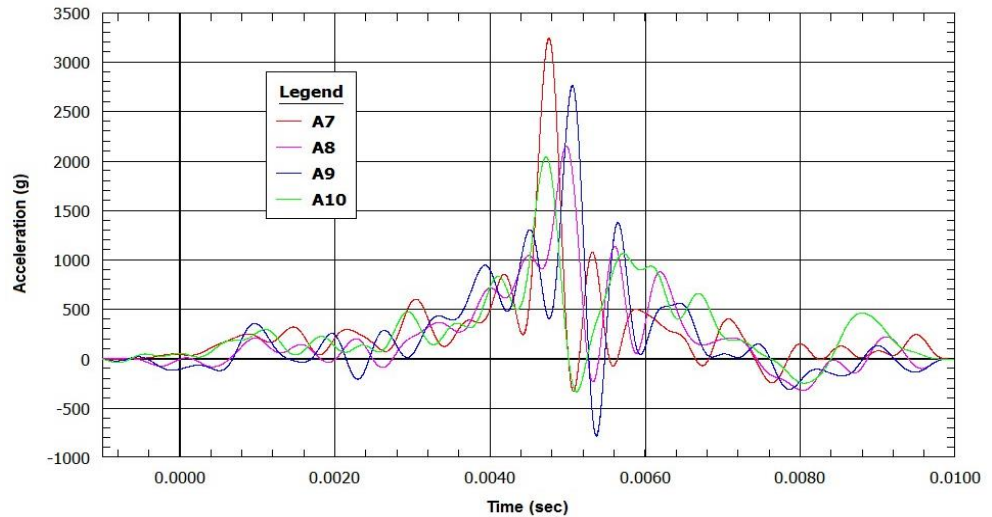
**b) 36-meter end drop**

**Figure 6 – Deformed shapes and mid-height accelerations from the 20.25-meter end impact, the 36-meter end impact, and the 36-meter corner impact**

Figure 6 shows the deformed shapes and mid-height accelerations from the other three impact tests. Complete dimensional inspection results and response curves from the instrumentation are provided in a SETU Benchmark Test Results SAND report [4].

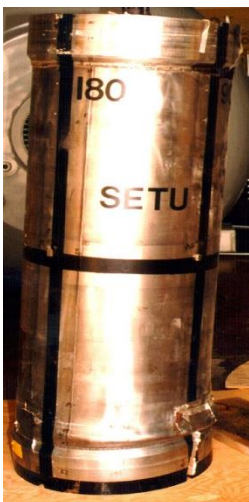
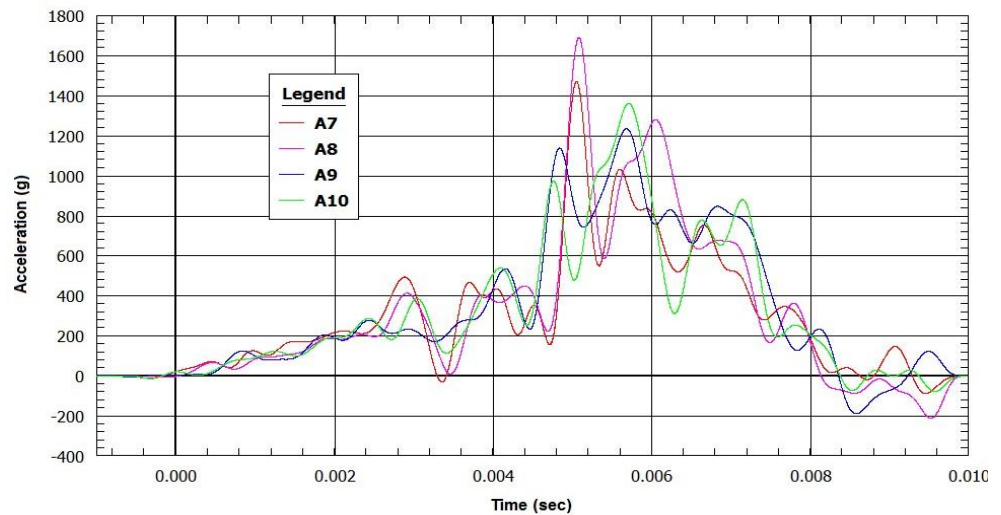
**c) 36-meter corner drop**
