In-Service Analysis of Cask Contamination Weeping*

P.C. Bennett¹, B. Teer², M. Mason², K. Lester², P. Paquin³, H. Shankhan⁴

¹Sandia National Laboratories⁵⁶, Albuquerque, New Mexico

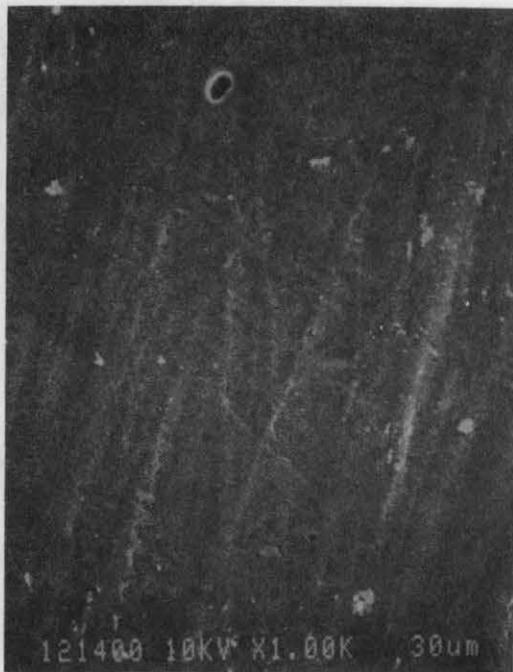
Figure 3. RSI-C1 Replication, Non-weeping Surface

Surface replications were made at three different times: July, October, and December of 1988. Prior to the first replication, the weeping area was cleaned and decontaminated. The replication itself (RSJ) was damaged and unfit for SEM examination. The October replications (RSI series) consisted of two weeping and two non-weeping samples. Figure 3 shows the non-weeping surface. The striations could be a randomly scratched metal surface with distributed low-atomic weight debris. No distinct grain boundaries are visible in this surface. Figure 4, which is a replicated weeping surface, displays a relatively clear etched grain structure.
