**POTENTIAL EUTECTIC FAILURE MECHANISM
FOR STAINLESS STEEL CANS CONTAINING PLUTONIUM METAL**

Hanchung Tsai, Yung Liu, Allen Smith,¹ Nick Gupta,¹ and Steve Bellamy¹

Argonne National Laboratory
Argonne, IL 60439

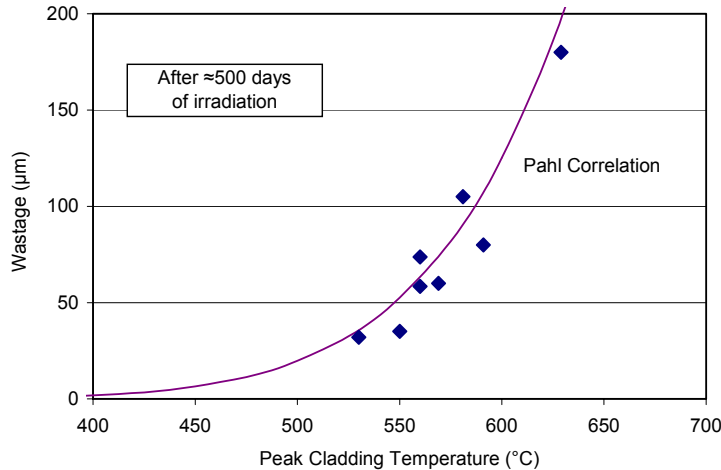
Note that the time term in Eq. (2) is subtracted by 158 days, the average incubation time assumed to attain fuel-cladding contact. Figure 1 shows the calculated cladding wastage from the Pahl correlation (curve), along with several measured data after ≈ 500 days of irradiation (diamonds). The cladding wastage in the IFR pins is $<150 \mu\text{m}$ after 500 days at 600°C peak cladding temperature.

Figure 1. IFR cladding wastage from steady-state irradiation

Using Eq. 2, one can estimate the depth of the reaction zone in the 3013 can during a hypothetical fire of 10 days at a Pu/SS interface temperature of 600°C . The calculated depth of reaction in the can wall is $\approx 21 \mu\text{m}$, which poses no threat to the integrity of the 3013 cans.

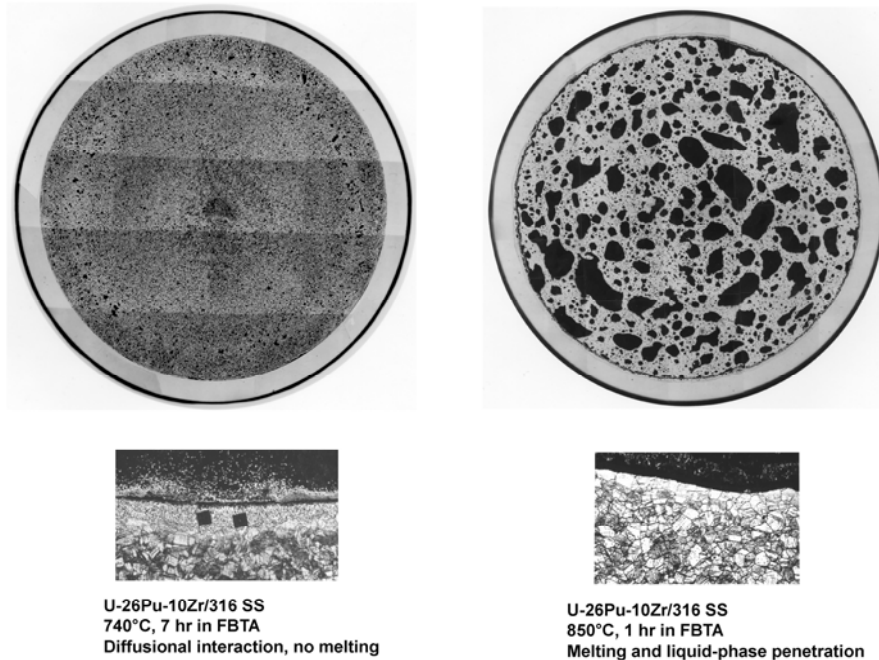
Over 130 FBTA tests were conducted, of which 92 used Pu-bearing fuels. The test temperature ranged from 625 to 800°C, and the test duration ranged from 5 minutes to 36 hours. After each test, the sample, a short segment of fuel pin, was transversely sectioned and polished. The cross section was examined on a metallograph to determine the extent of melting and cladding penetration. No interfacial melting was noted in any test with temperature $\leq 650^\circ\text{C}$, even with extended test durations (up to 36 hours). Above 675°C, melting was observed in some samples with longer test durations. Figure 2 shows the results from tests with and without melting.

Figure 2. Cross-sectional view of two samples after the FBTA tests. Samples were from the same fuel pin. No fuel or fuel/cladding interface melting in the sample shown on the left (740°C, 7 h). The lower photos show etched cladding and the nature of the diffusion cladding penetration. (The black diamonds in the cladding diffusion layer on the left are the indentation marks from microhardness measurements.) Notice that for the sample on the right (850°C, 1 h), while liquefaction affected the entire fuel cross section, the cladding is still largely intact. The thickness of cladding for this pin is 381 μm (0.015 in.).

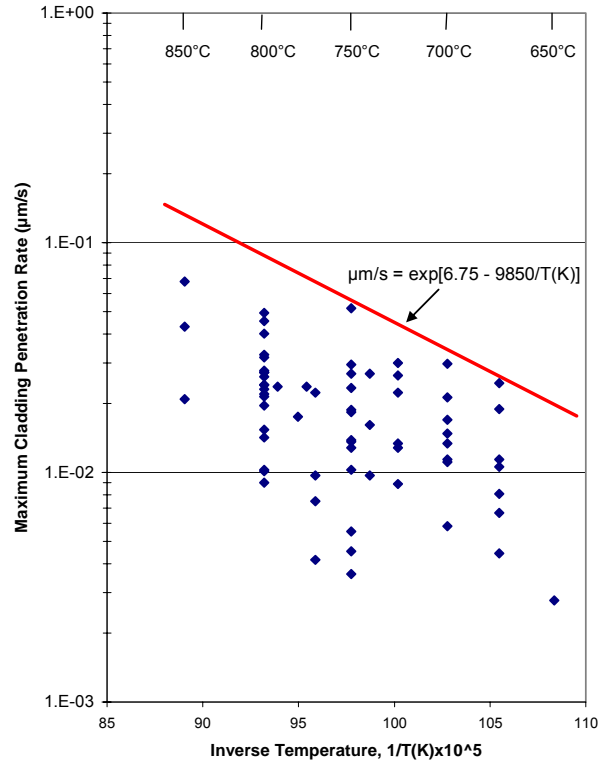
The rates of cladding penetration from all the FBTA tests with a one-hour duration are shown in Fig. 3. (Penetration rate is defined as the measured maximum penetration divided by the 1.0-h test duration; it represents an effective rate and includes the accelerated penetration at the onset of heating.) Data scatter in the plot is due mainly to the wide variability of material, irradiation conditions, and fuel burnup. An Arrhenius correlation is shown in the figure that bounds the data band. This empirical correlation, given by Eq. (3) below, may be suitable for estimating the rate of wall thinning in a 3013 can during an elevated-temperature fire:

Figure 3. Effective cladding penetration rates from the FBTA tests for specimens tested for 1.0 hour

Based on Eq. (3), the calculated wall thinning rate is $\approx 0.088 \mu\text{m/s}$ for a fire that produces a Pu/SS 3013 can temperature of 800°C . The depth of wall penetration would be $\approx 320 \mu\text{m}$ after one hour, and approximately 60% of the 3013 can wall ($\approx 5,600 \mu\text{m}$, inner and outer walls combined) would have been reacted after 10 hours at 800°C .

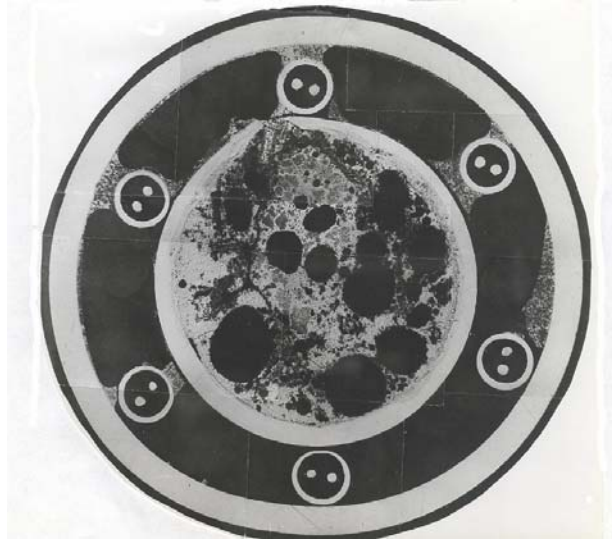
Figure 4. Cross-sectional view of a IFR fuel pin (U-19 wt.% Pu-10 wt.% Zr/HT9) that failed near the top end of the fuel after 112 minutes at 820°C. The fuel pin is shown in the center of the picture surrounded by six thermocouples in the gap between the fuel pin and a furnace heat receptor. Cladding breaching occurred near 12 o'clock with a very substantial wall thinning due to fuel/cladding metallurgical interaction, aided by fission-gas pressure loading. The fuel has completely liquefied, or "foamed," with various coalesced fission gas bubbles (or voids), a few with diameters as large as half the radius of the fuel.

internal fission gas pressure that resulted in the final rupture of the cladding (Fig. 4). Based on Eq. (3) derived from the FBTA data of 1-h tests, approximately 60% of the 3013 can wall ($\approx 5,600 \mu\text{m}$ combined inner and outer walls) would be reacted after 10 h at 800°C .

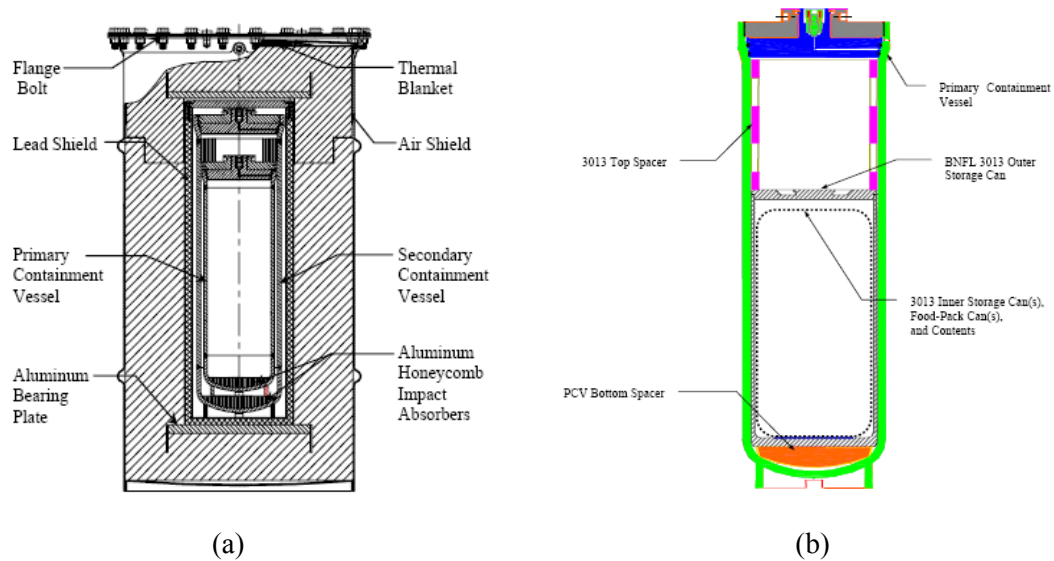
The purpose of the thermal analysis of the Model 9975 packaging, shown schematically in Figure 5, is to assess the Pu/SS interface temperature in the 3013 cans under different fire scenarios. A convenient

Figure 5. Schematic of the Model 9975 transportation packaging: (a) cross-sectional view and (b) primary containment vessel containing a 3013 can assembly. The hatched area in (a) between the lead shield and the drum surface is the Celotex thermal insulation.

A quasi-static approach has been adopted in the thermal analysis of the Model 9975 packaging that takes into account the shrinkage and charring of the Celotex (see Fig. 5a) during a fire. It consisted of a series of calculations, each for a 30-minute duration, with the thickness of the Celotex and the charred layer adjusted for succeeding calculations based on the results of the preceding calculation. Specifically, the results of a given case are reviewed, then the portion of Celotex above 260°C (500°F) is removed, and the portion above 149°C (300°F) is assigned the thermal properties of a charred layer before the next calculation is repeated. The temperature criteria are based on a study of thermal degradation of Celotex,¹⁸ as well as the previous thermal analysis of a HAC test of a Model 9975 packaging conducted in the Radiant Heat Facility at Sandia National Laboratories.¹⁹ The HAC thermal test was conducted at 816°C for 30 minutes, followed by a 15-hour cool-down while the Model 9975 packaging remained in the test facility. Temperatures were recorded for 16 hours from the start of heating, and the peak temperature for the primary containment vessel occurred 9 hours after the start of heating. By the end of 16 hours, the outer components were near the pre-test temperatures.

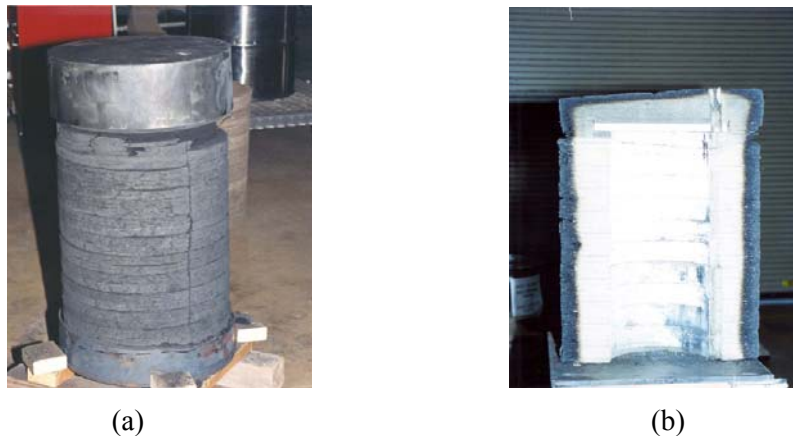
Post-test examination of the Model 9975 packaging found that the Celotex was uniformly charred over its outer surface (Fig. 6a), and its outside diameter was reduced by ≈ 2 cm. While the bulk of the Celotex ring segments maintained their configuration, portions near the top had broken off, and a web of fissures and cracks was evident on the surface. The thickness of the charred layer in the Celotex, shown in Fig. 6b

Figure 6. Outside surface of the Celotex ring segments after the HAC thermal test of a Model 9975 packaging, (a), and cross-sectional view of the Celotex showing the charred outer layer, (b).

along the rim, is ≈ 4 cm, giving a total thickness of ≈ 5.2 cm of shrinkage and charred Celotex during the HAC thermal test. Since the original thickness of the Celotex ring segment is 12.8 cm (5 in.), the shrinkage and the charred layer are ≈ 15 and 30%, respectively, of the original thickness of the Celotex

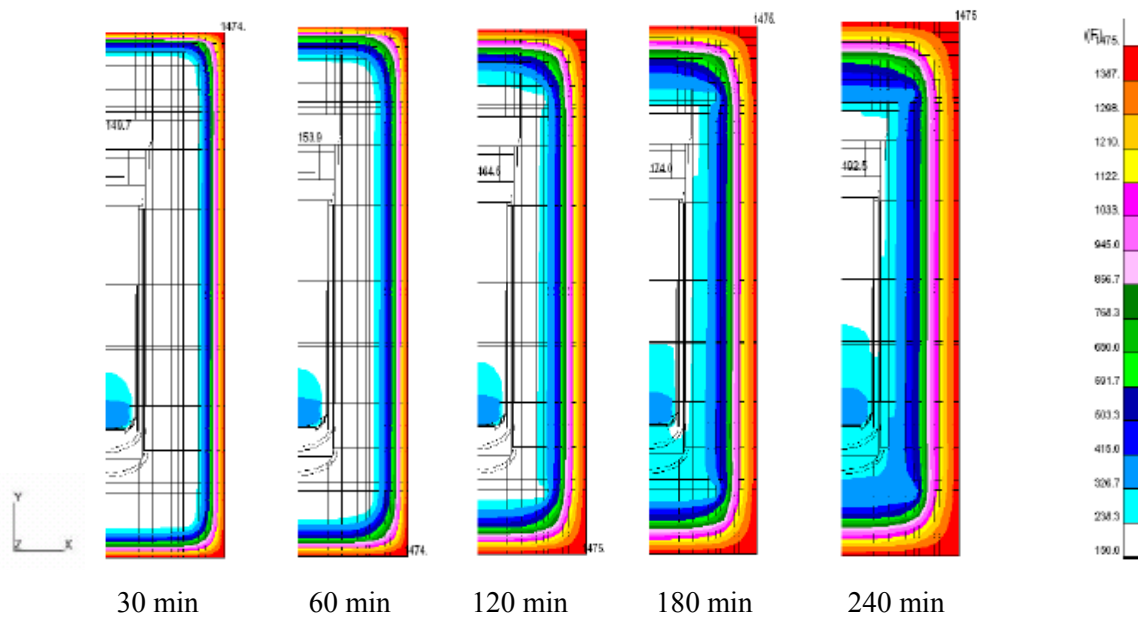
Figure 7 shows snapshots of the calculated temperature distributions in the various components of the Model 9975 packaging during an 800°C fire after 30, 60, 120, 180, and 240 minutes. Only halves of the packagings are shown, assuming shrinkage and charring of the Celotex were symmetrical about the center axis. The 3013 can shown along the center axis contains two stacked Pu buttons with a heat load of 19 W, and the calculated Pu/can interface temperature increases slowly with time, from 162°C after 30 minutes to 187°C after 240 minutes at 800°C. While the results may be encouraging, these calculated Pu/can interface temperatures are subject to considerable uncertainties in the values assumed for the shrinkage and the thermal physical properties and the thickness of the charred layer, which may not be conservative. In addition, the thermal model has not accounted for heat transfer through the gaps between the Celotex ring segments, or the cracks and fissures through the Celotex.

Figure 7. Calculated temperature distributions in the Model 9975 packaging during a 4-h, 800°C (1472°F) fire. (Temperature scale in degrees Fahrenheit.)

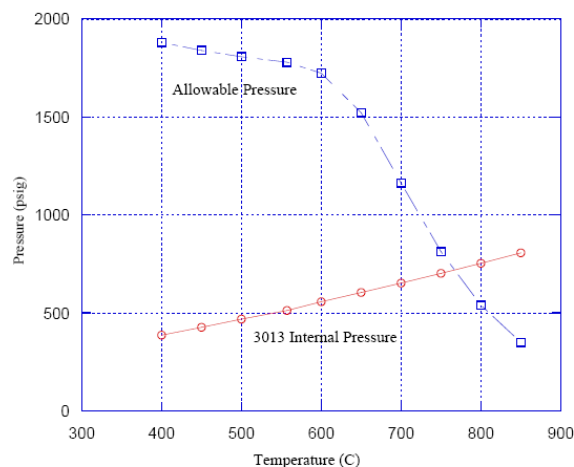
For the pressure loading inside the 3013 can during a fire, Gupta and McKeel considered contributions from the generation of hydrogen (from radiolysis) and helium (from alpha decay), steam from desorption of moisture, and heating. They calculated the pressure inside the 3013 can as a function of temperature, assuming that the content is plutonium oxide stabilized according to the procedures in DOE-STD-3013-2004. The calculated internal pressure varies between 386 and 806 psig at 400 and 850°C, respectively. Figure 8 shows the calculated internal pressure and the allowable pressure for the 3013 can in a 1.5-h duration fire, with a fire temperature ranging between 400 and 850°C. The two curves intersect at 767°C at an allowable pressure of 720 psig. For a 3013 can containing Pu metal, the internal pressure will be lower than that shown in Fig. 8 for plutonium oxide because of the lower moisture level in the Pu metal. The corresponding increase in the internal pressure with temperature in the 3013 can containing Pu metal, therefore, would be smaller, and the intersection with the allowable pressure would occur at a temperature higher than 767°C.

Figure 8. Allowable pressure for the 3013 can in a 1.5-h fire at various temperatures calculated from creep strain limits, and internal pressure in the 3013 can containing plutonium oxide calculated as a function of temperature.
