NCT/HAC Testing of 9981 Type AF Shipping Container

Fletcher Davis, Joshua Flach, Christopher Cable, Paul Blanton
Savannah River National Laboratory
Aiken, SC

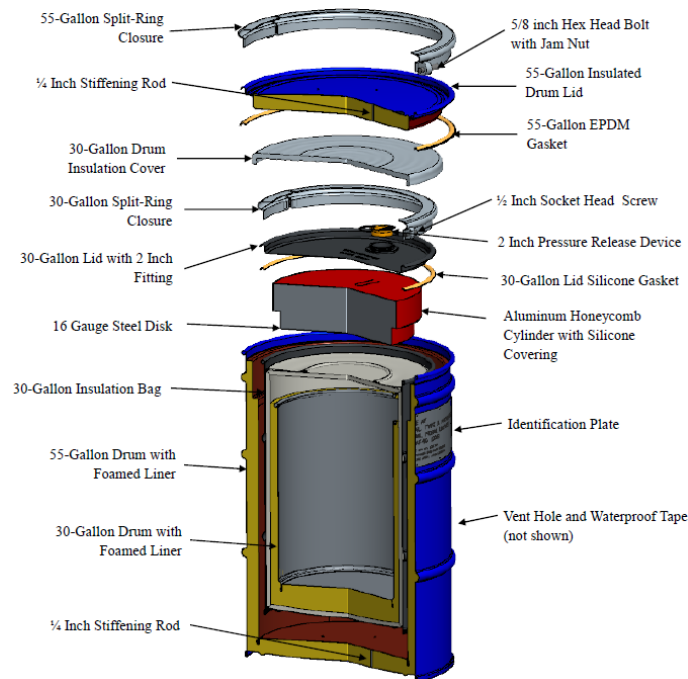
Figure 1 – 9981 Type AF Packaging Configuration

The 9981 incorporated several deviations from the 9979 to withstand a higher content weight payload. For example, the internal 30-gallon drum assembly was modified to include an internal steel liner and a polyurethane foam layer between the steel surfaces. An aluminum honeycomb cylinder with a silicon lining was also located between the top of the steel liner and the inside of the 30-gallon drum lid for energy absorption. Last, 1/4" stiffening rods were added to the bottom of the 55-gallon drum to provide additional structural support. Both the top curl and bottom chime were welded as well. These changes created a more robust container capable of withstanding accident conditions with heavier/denser payloads.

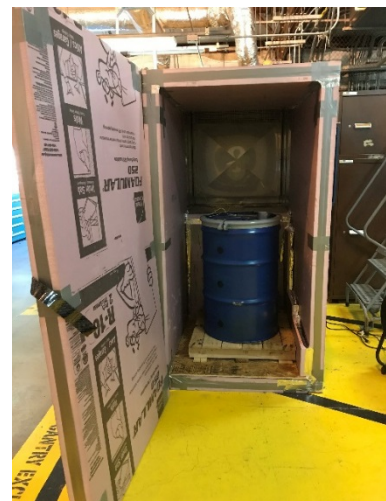
suggested constructing an insulated extension to the thermal chamber that could be mated to the thermal chamber for additional volume. This chamber modification is similar to the construction of modular walk-in environmental chambers and allows for significantly greater cooling volume. Additionally, rigging operations were made significantly easier due to the floor level elevation of the package. The insulation was sufficient to limit the loss of efficiency for the thermal chamber even with the increased volume.

The final challenge that was encountered during the test preparations was regarding the structural capacity of the available thermal chamber in 781-A. The thermal chamber was not structurally designed to handle the weight of the 9981 package and it was undetermined whether the support structure would be strong enough to support the package weight without modification. Furthermore, the chamber was lofted approximately 3 feet from the floor and was only marginally larger than the longest dimension of the package, which raised concerns regarding rigging operations. A thermal chamber with a larger payload capacity was not available.

The initial plan was to reinforce the support structure for the thermal chamber; however, this plan did not address the issues with loading and unloading the package. It was unclear whether the temporary structural support would adequately reinforce the chamber. The structural engineer supporting the project

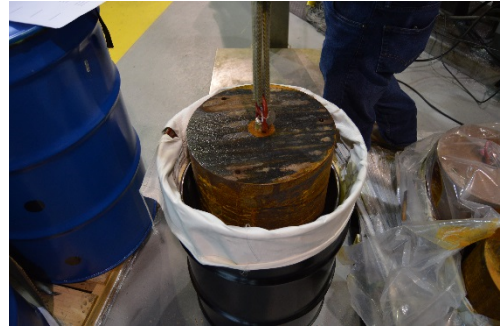
Four prototype 9981 packagings were used to conduct the required regulatory testing depicted in the test plan over the course of two days. Prior to conducting the regulatory performance tests, simulated contents were loaded. The simulated container content was created to simulate a worst-case content, which was a single object at the maximum content weight for the container. The SRS machine shop fabricated steel weights (362 lbs \pm 3 lbs) and installed a swivel hook on each weight to allow for loading. Each container had a combination of flour and fluorescent powder added to the top and bottom of the 30-gallon drum to provide a clear indication if the drum's containment boundary was compromised during the testing.

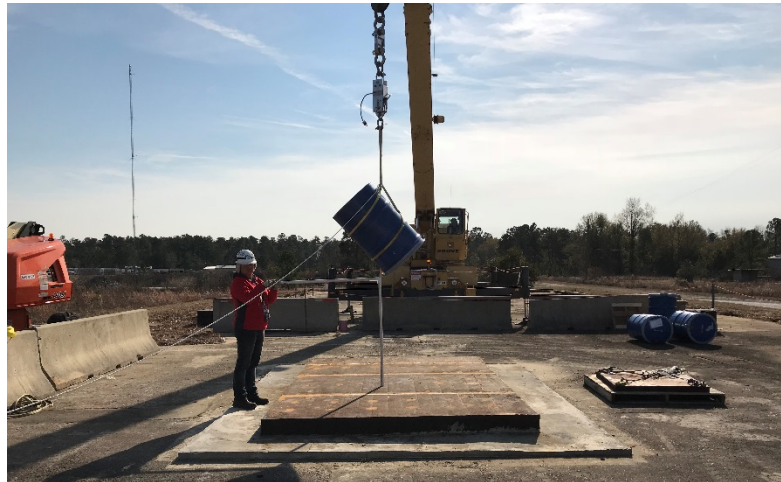
Both SN-002X and SN-004X struck the drop pad on the closure lug and rebounded to experience a second impact where the bottom of the drum struck the pad. Both impacts resulted in scuffing of the paint on the closure lugs, slight compression of the closure lugs, very minor deformation of the clamshell closure, and minor flattening of the bottom chime of the container.

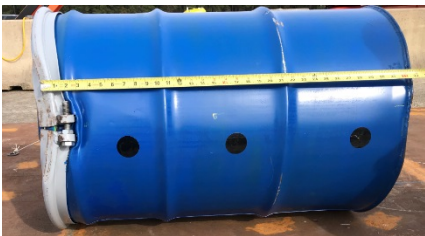
The 30-ft drop test of SN-002X was performed with the package oriented with the center-of-gravity-over-top-edge (CGOT) such that the package would impact on the closure lugs. The impact resulted in compressing the closure lugs into the side of the drum and deforming the clamshell closure device. There was a small amount of bowing in the lid, and the bottom chime had a slight flat spot from the secondary impact.

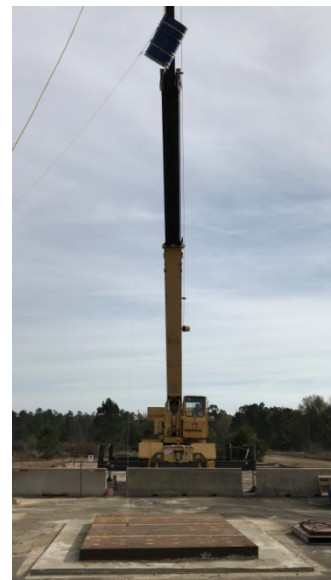
SN-004X was oriented vertically-top-down for the 30-ft drop test. The impact resulted in half of the clamshell closure being depressed, slight damage to the closure lugs, and a single stiffening pin was externally depressed.

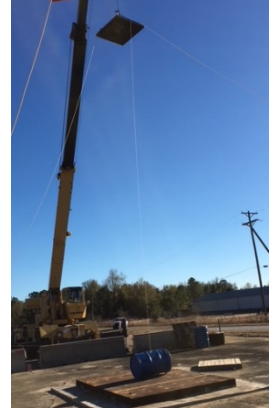
All four prototype packages underwent the 30-ft crush test [10 CFR 71.73(c)(2)]. The crush test was performed immediately after the 30-ft drop test in each instance. For the crush test, SN-001X was placed horizontally on the drop pad. The package was oriented such that one set of closure lugs rested on the plate, and the other set would be impacted by the crush plate. The crush plate struck the package nearly horizontally, rebounded, and struck the bottom of the drum. The impact resulted in localized buckling of the clamshell closure because of the drop/crush tests. After the crush test, further damage to the clamshell could be observed. Both closure lugs were pressed inward and the bottom of the drum was flattened. The bottom chime was flattened but remained intact. Both the top and bottom of the drum were creased due to the crushing effect. In addition, the secondary impact left a dent near the bottom of the drum where the corner of the plate impacted the drum.
